**Supporting Documentation**

**Property: 23900 E. Ohio Ave. Aurora, CO**

**Owner: Garcia, Fernando Avina**

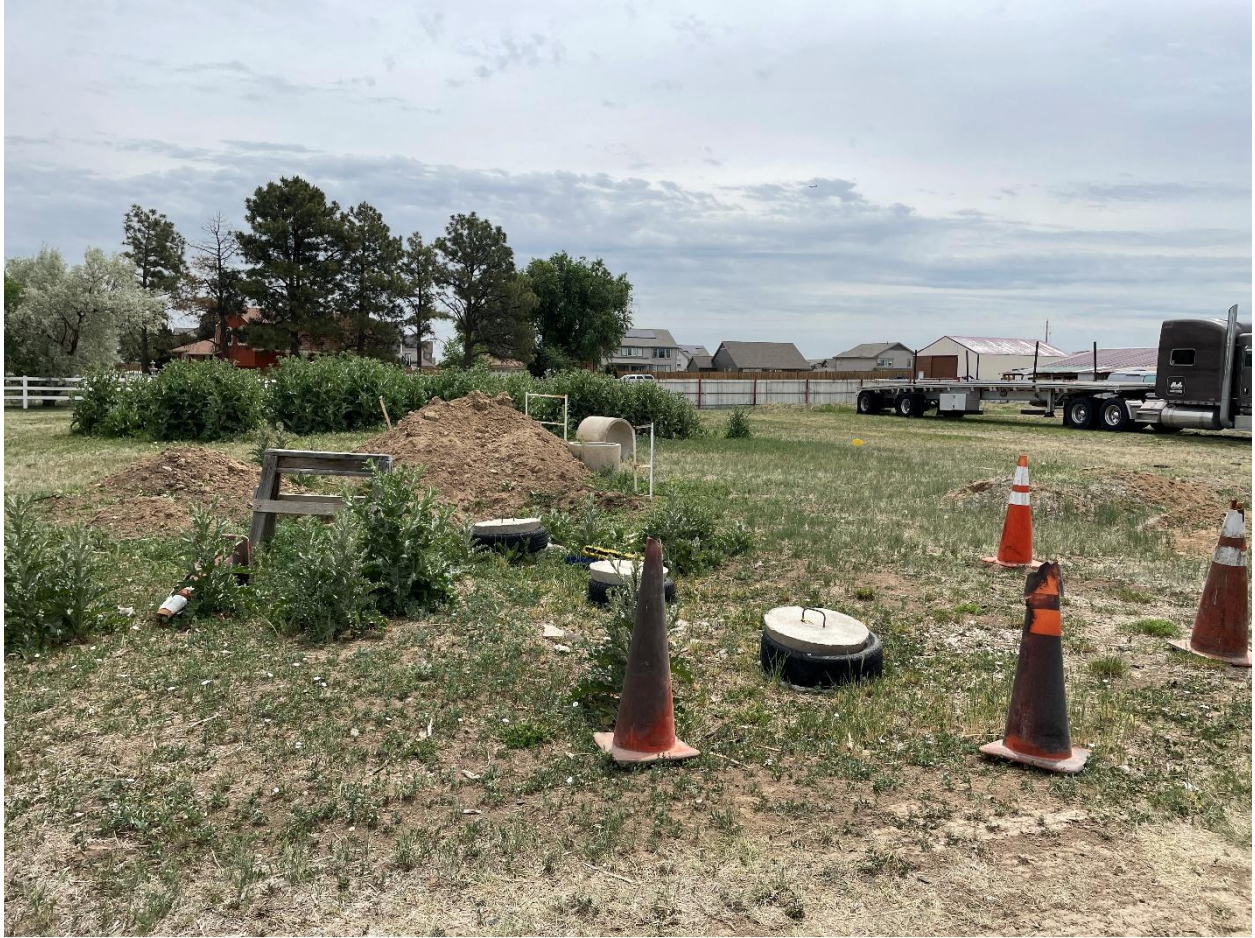
View of septic tank lids

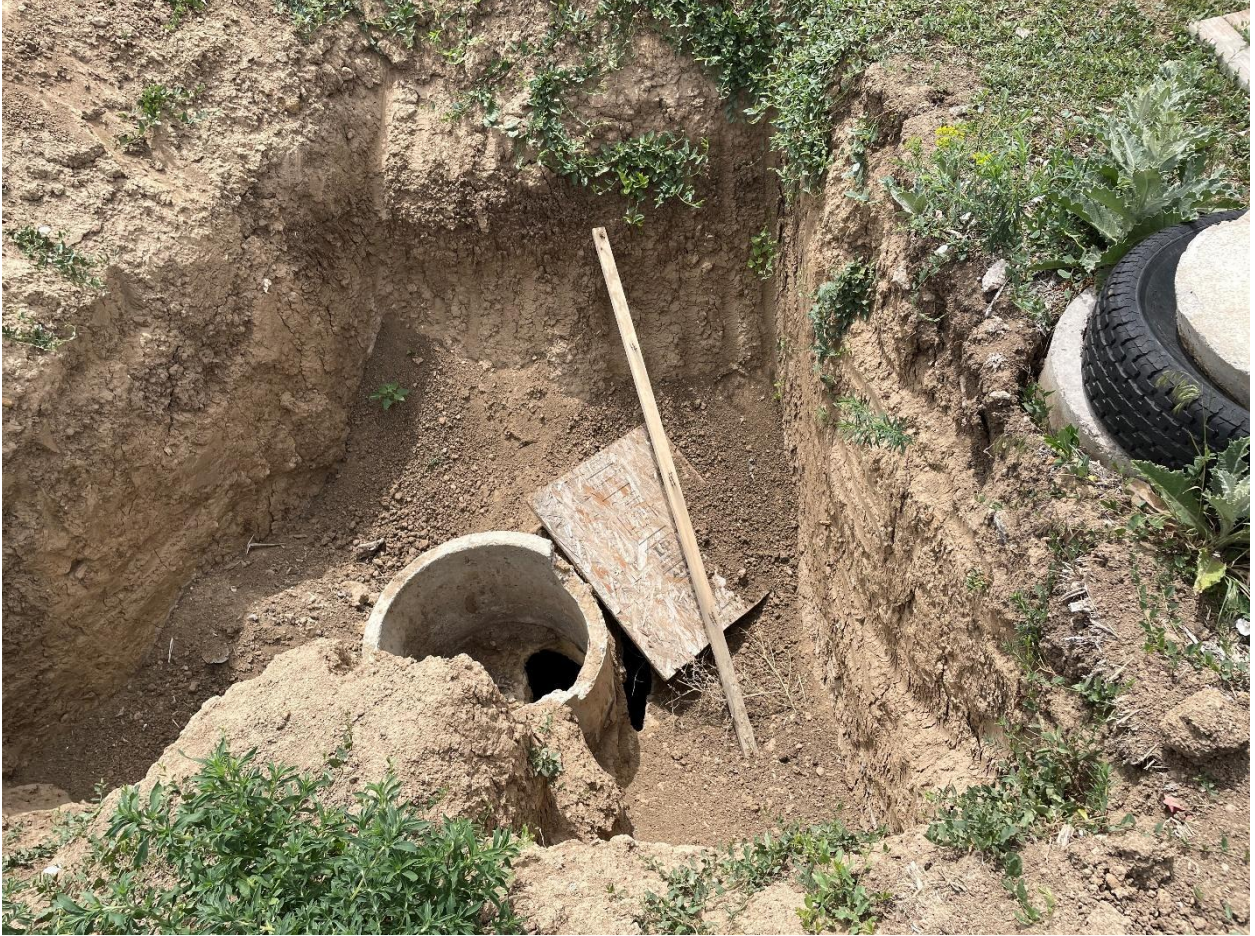
View of excavation

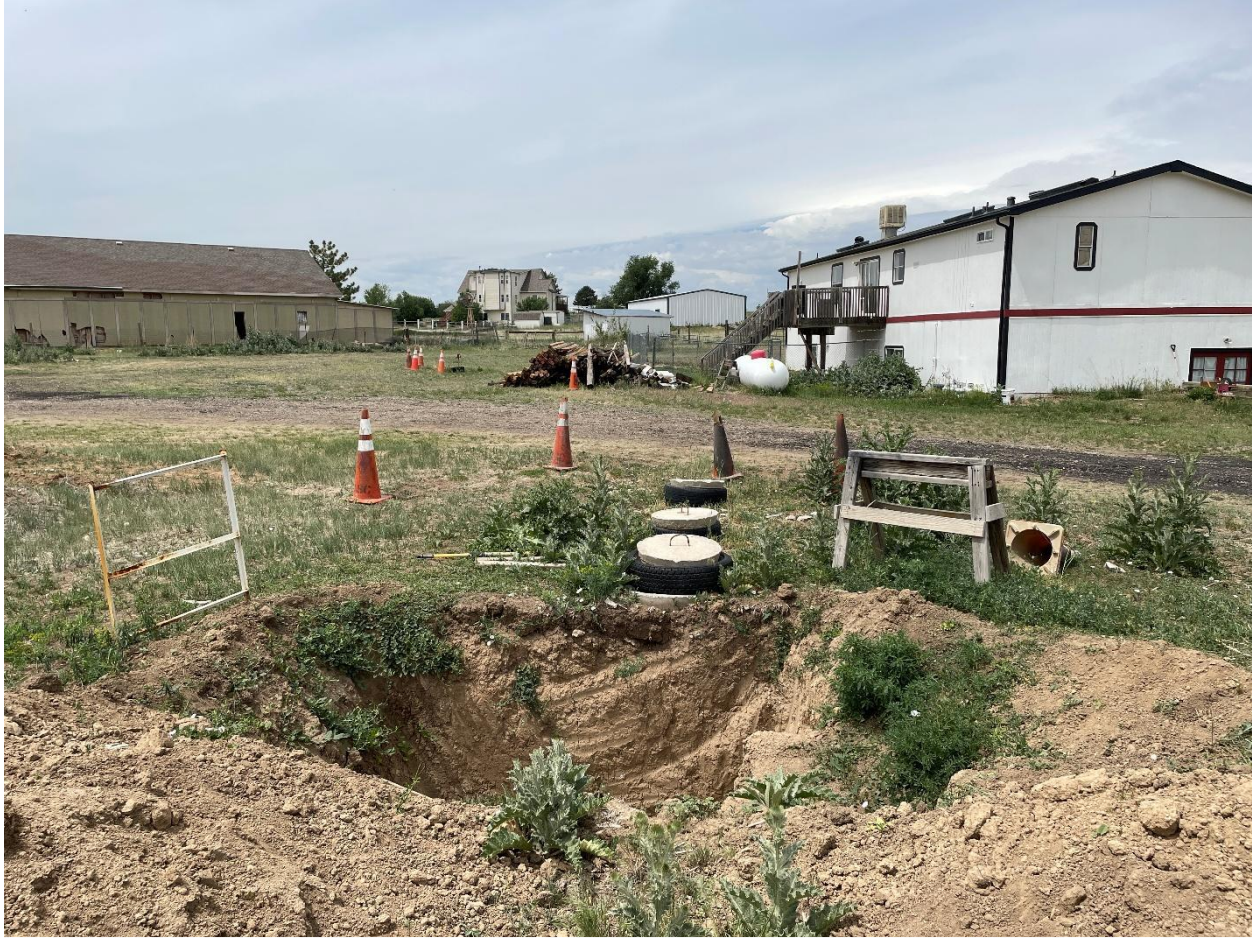
View of excavation

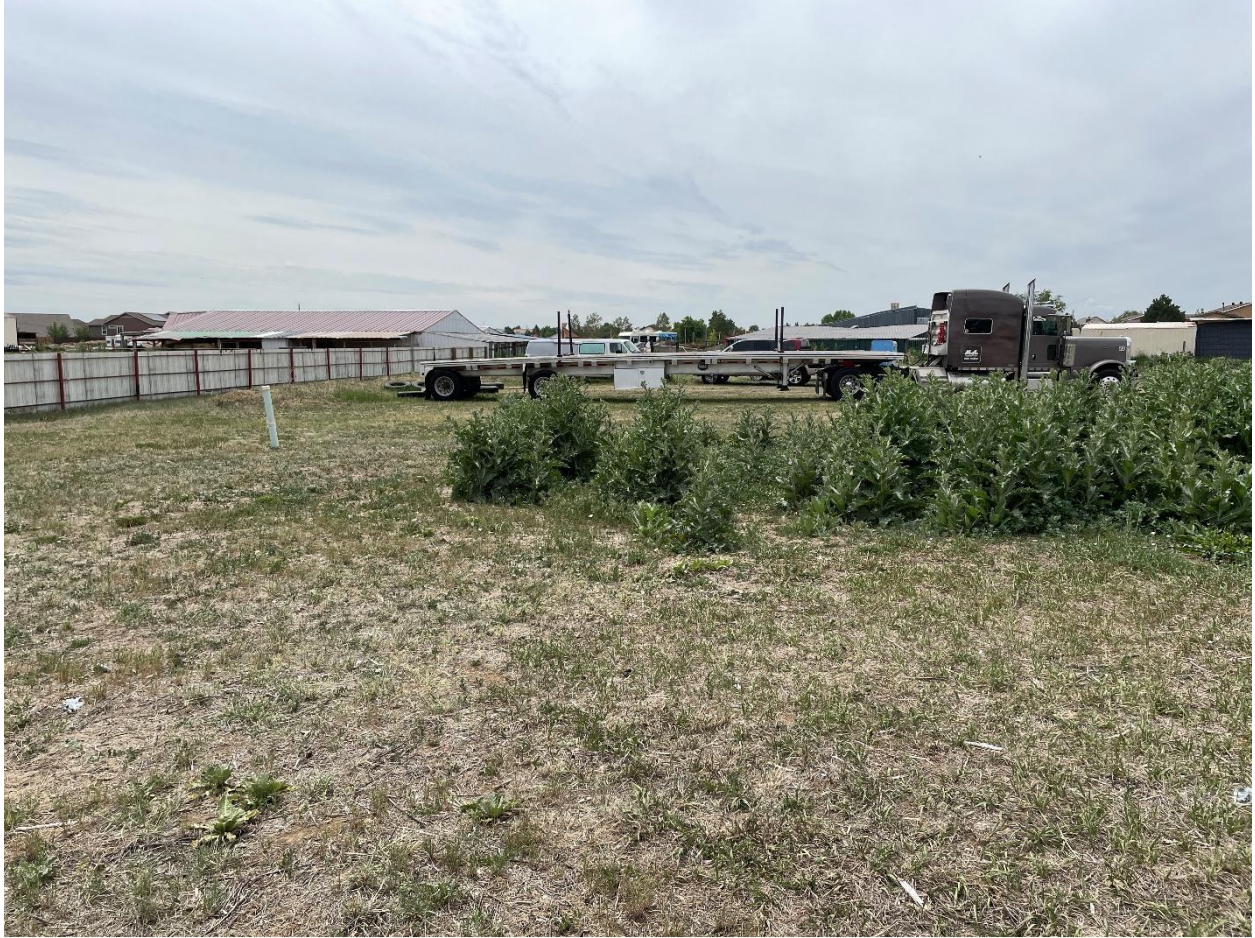
View of soil treatment area and observation port

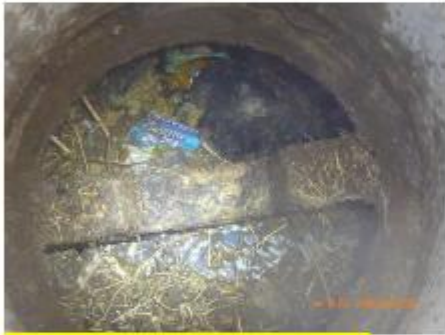
Inlet access port opening – primary tank

We recommend adding exterior lids to the primary tank.

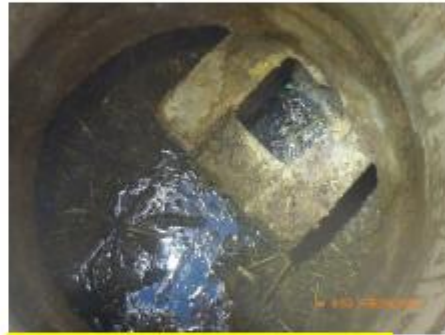
Outlet access port opening – primary tank

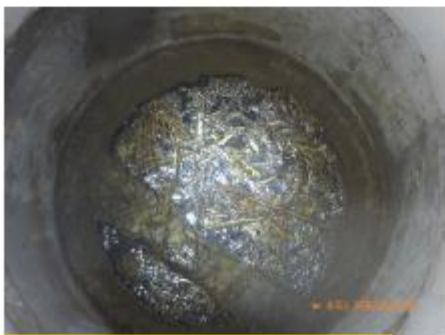
Inlet access port opening – secondary tank

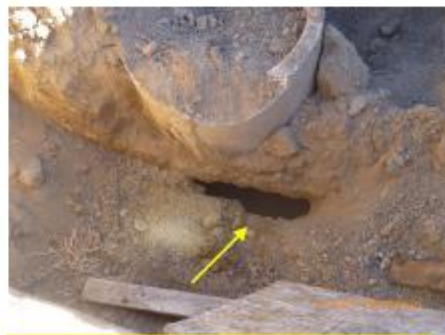
The secondary tank has severe deterioration present and damage from the excavator.

Outlet access port – secondary tank – Damage from the excavator.

We recommend replacing the secondary tank.

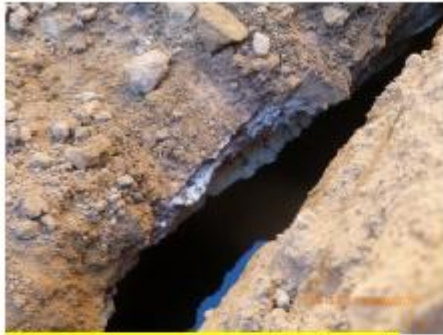
**Tank Integrity:** The primary tank appears to be in good condition with no apparent cracks or leaks present at the time of this inspection. The secondary tank appears to be in poor condition at the time of this inspection. There is severe deterioration present. The tank was damaged by the company that came to do the initial inspection. However, the outlet side of the secondary tank was easily penetrated with a probe, through the lid and alongside the outlet riser.

Hole at outlet access port – secondary tank

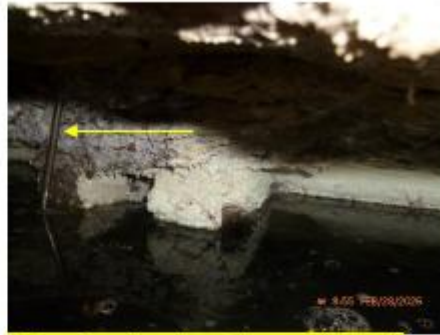
Probe through outlet wall – secondary tank

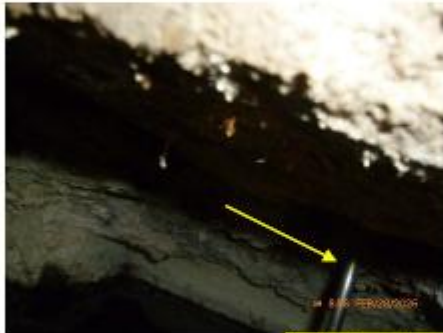
Probe through outlet wall – secondary tank

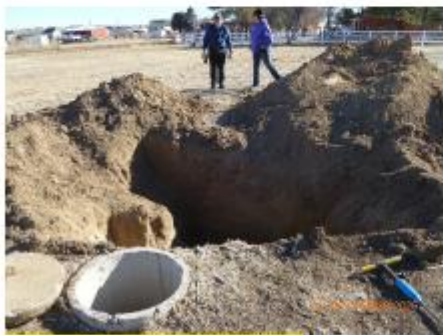
**Components of absorption area:** There is a diverter valves approximately 12.6' from the outlet side of the secondary tank. The diverter valve was inaccessible at the time of this inspection. Due to the depth and lack of device to pull the diverter valve out we were unable to assess its condition at the time of this inspection. There was evidence that the wastewater had risen up into the diverter valve casing, there was a personal wipe near the top of the casing.

Tank to diverter valve facing east

We recommend excavating the diverter valve and cleaning out the debris to evaluate its condition. If it is found in good condition, we recommend bringing the diverter valve to grade for access and to be able to switch between the two existing fields.

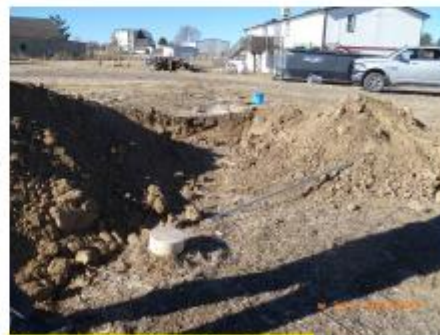
Diverter valve to tank facing west

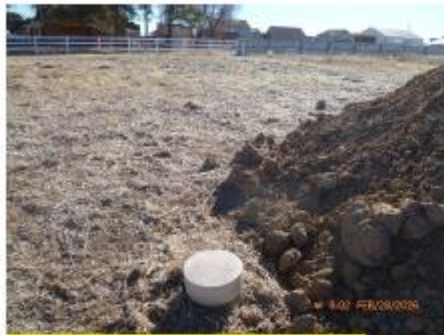
**Soil Conditions at the time of inspection:** Due to the depth of the STA, we are unable to determine the condition of both fields at the time of this inspection.

Diverter valve to STA 1 facing southeast

We recommend additional investigation be completed to assess the fields. When the diverter valve is excavated, it would be the time to run the line camera down to effluent line to assess the condition of the two fields. If the fields have never been switched, it is possible to utilize the field that was not receiving the effluent and allow the other field to rest and possibly return to use in the future. If both fields have been receiving effluent and have developed a thick biomass, it may be necessary to abandon these fields and install new fields.

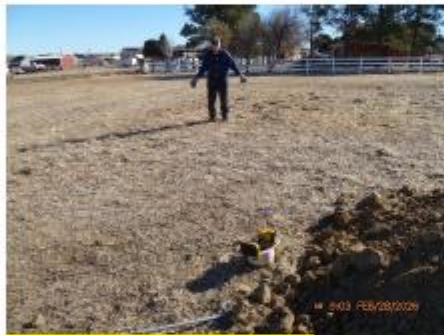
Diverter valve to STA 2 facing east

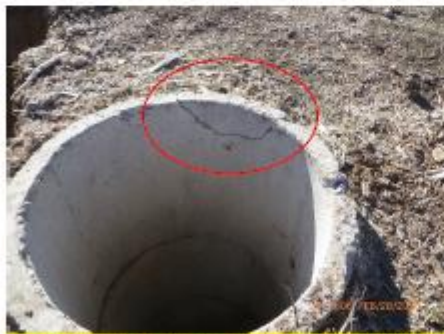
Cracked riser on inlet access port – secondary tank

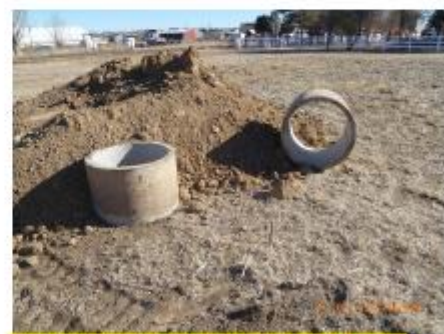
Risers removed from secondary tank outlet

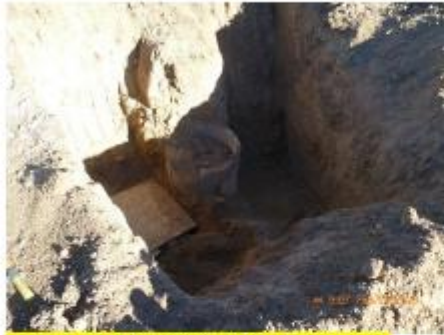
Secondary tank outlet – dug up previously
