**Natural Resources Assessment
Box Elder Creek Well Field 2
East Quincy Avenue to County Road 194
Arapahoe County, Colorado**

ERO Resources Corporation
1626 Cole Boulevard, Suite 100
Lakewood, Colorado 80401
(303) 830-1188
ERO Project #20_054

June 13, 2024

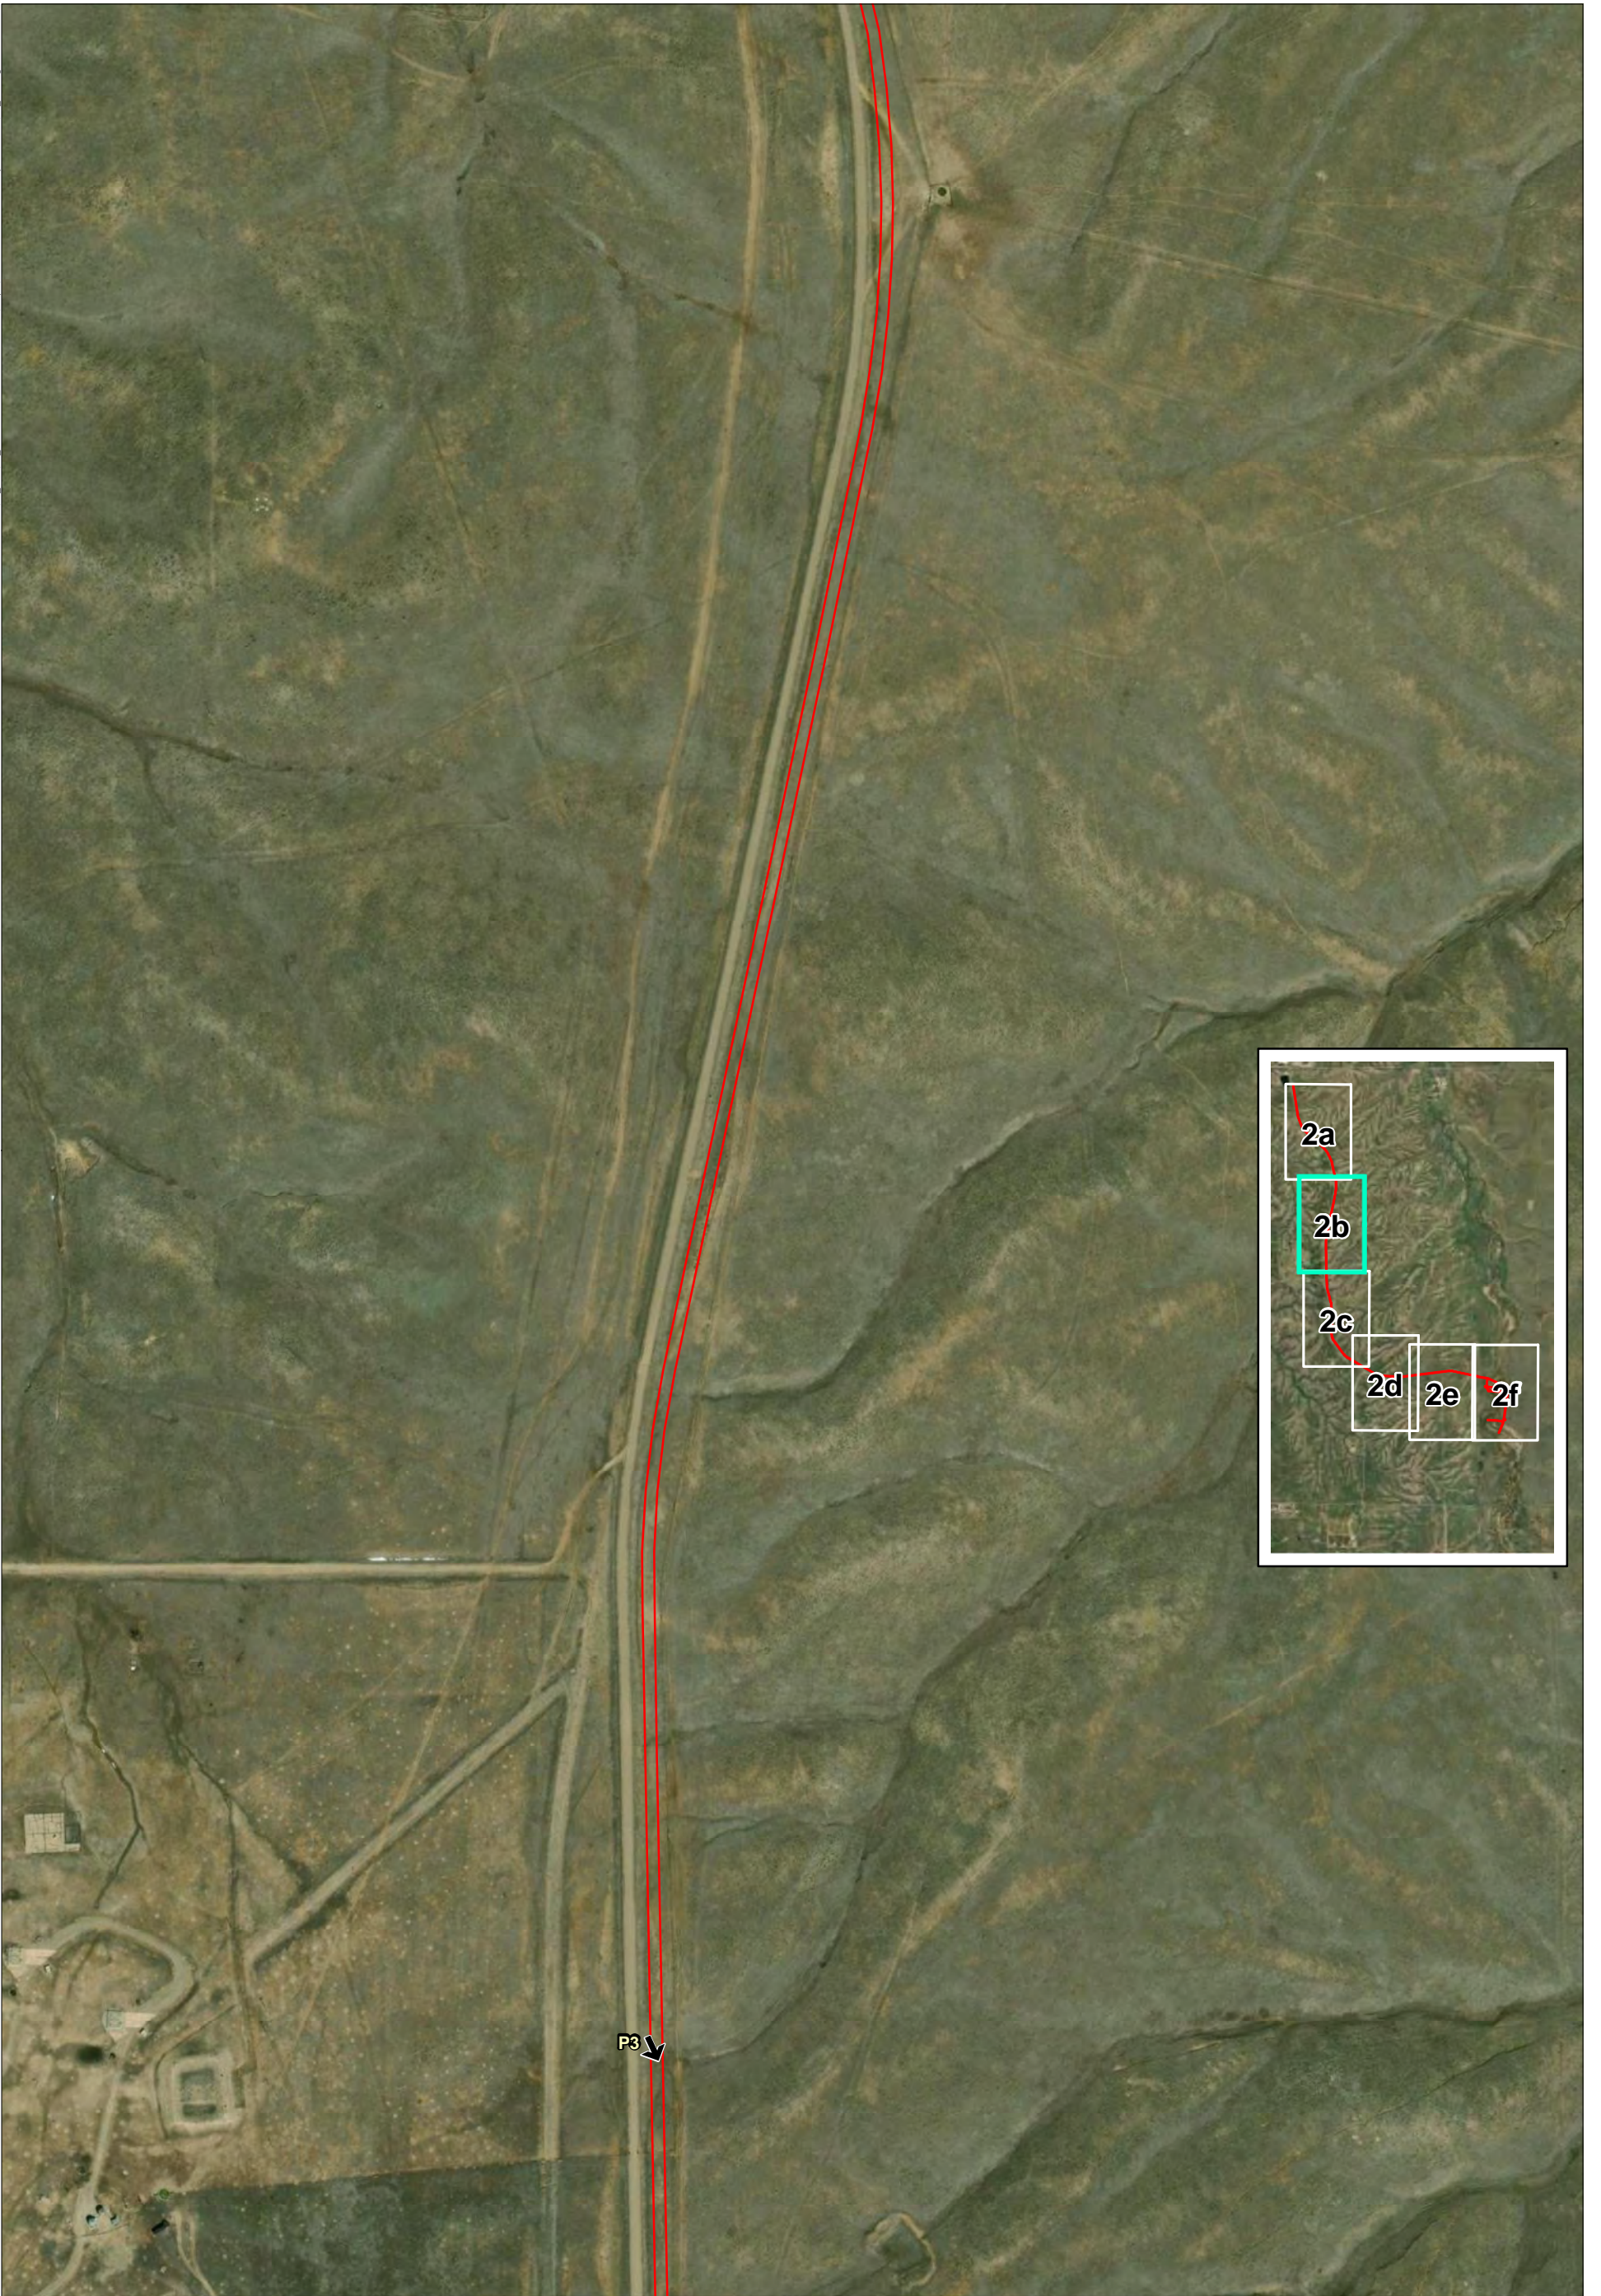
**Figure 2b
Existing Conditions**

- Data Point
- ➔ Photo Point
- Upland Vegetated Swale
- Limit of Delineation
- 🐕 Active Prairie Dog Colony
- Project Area

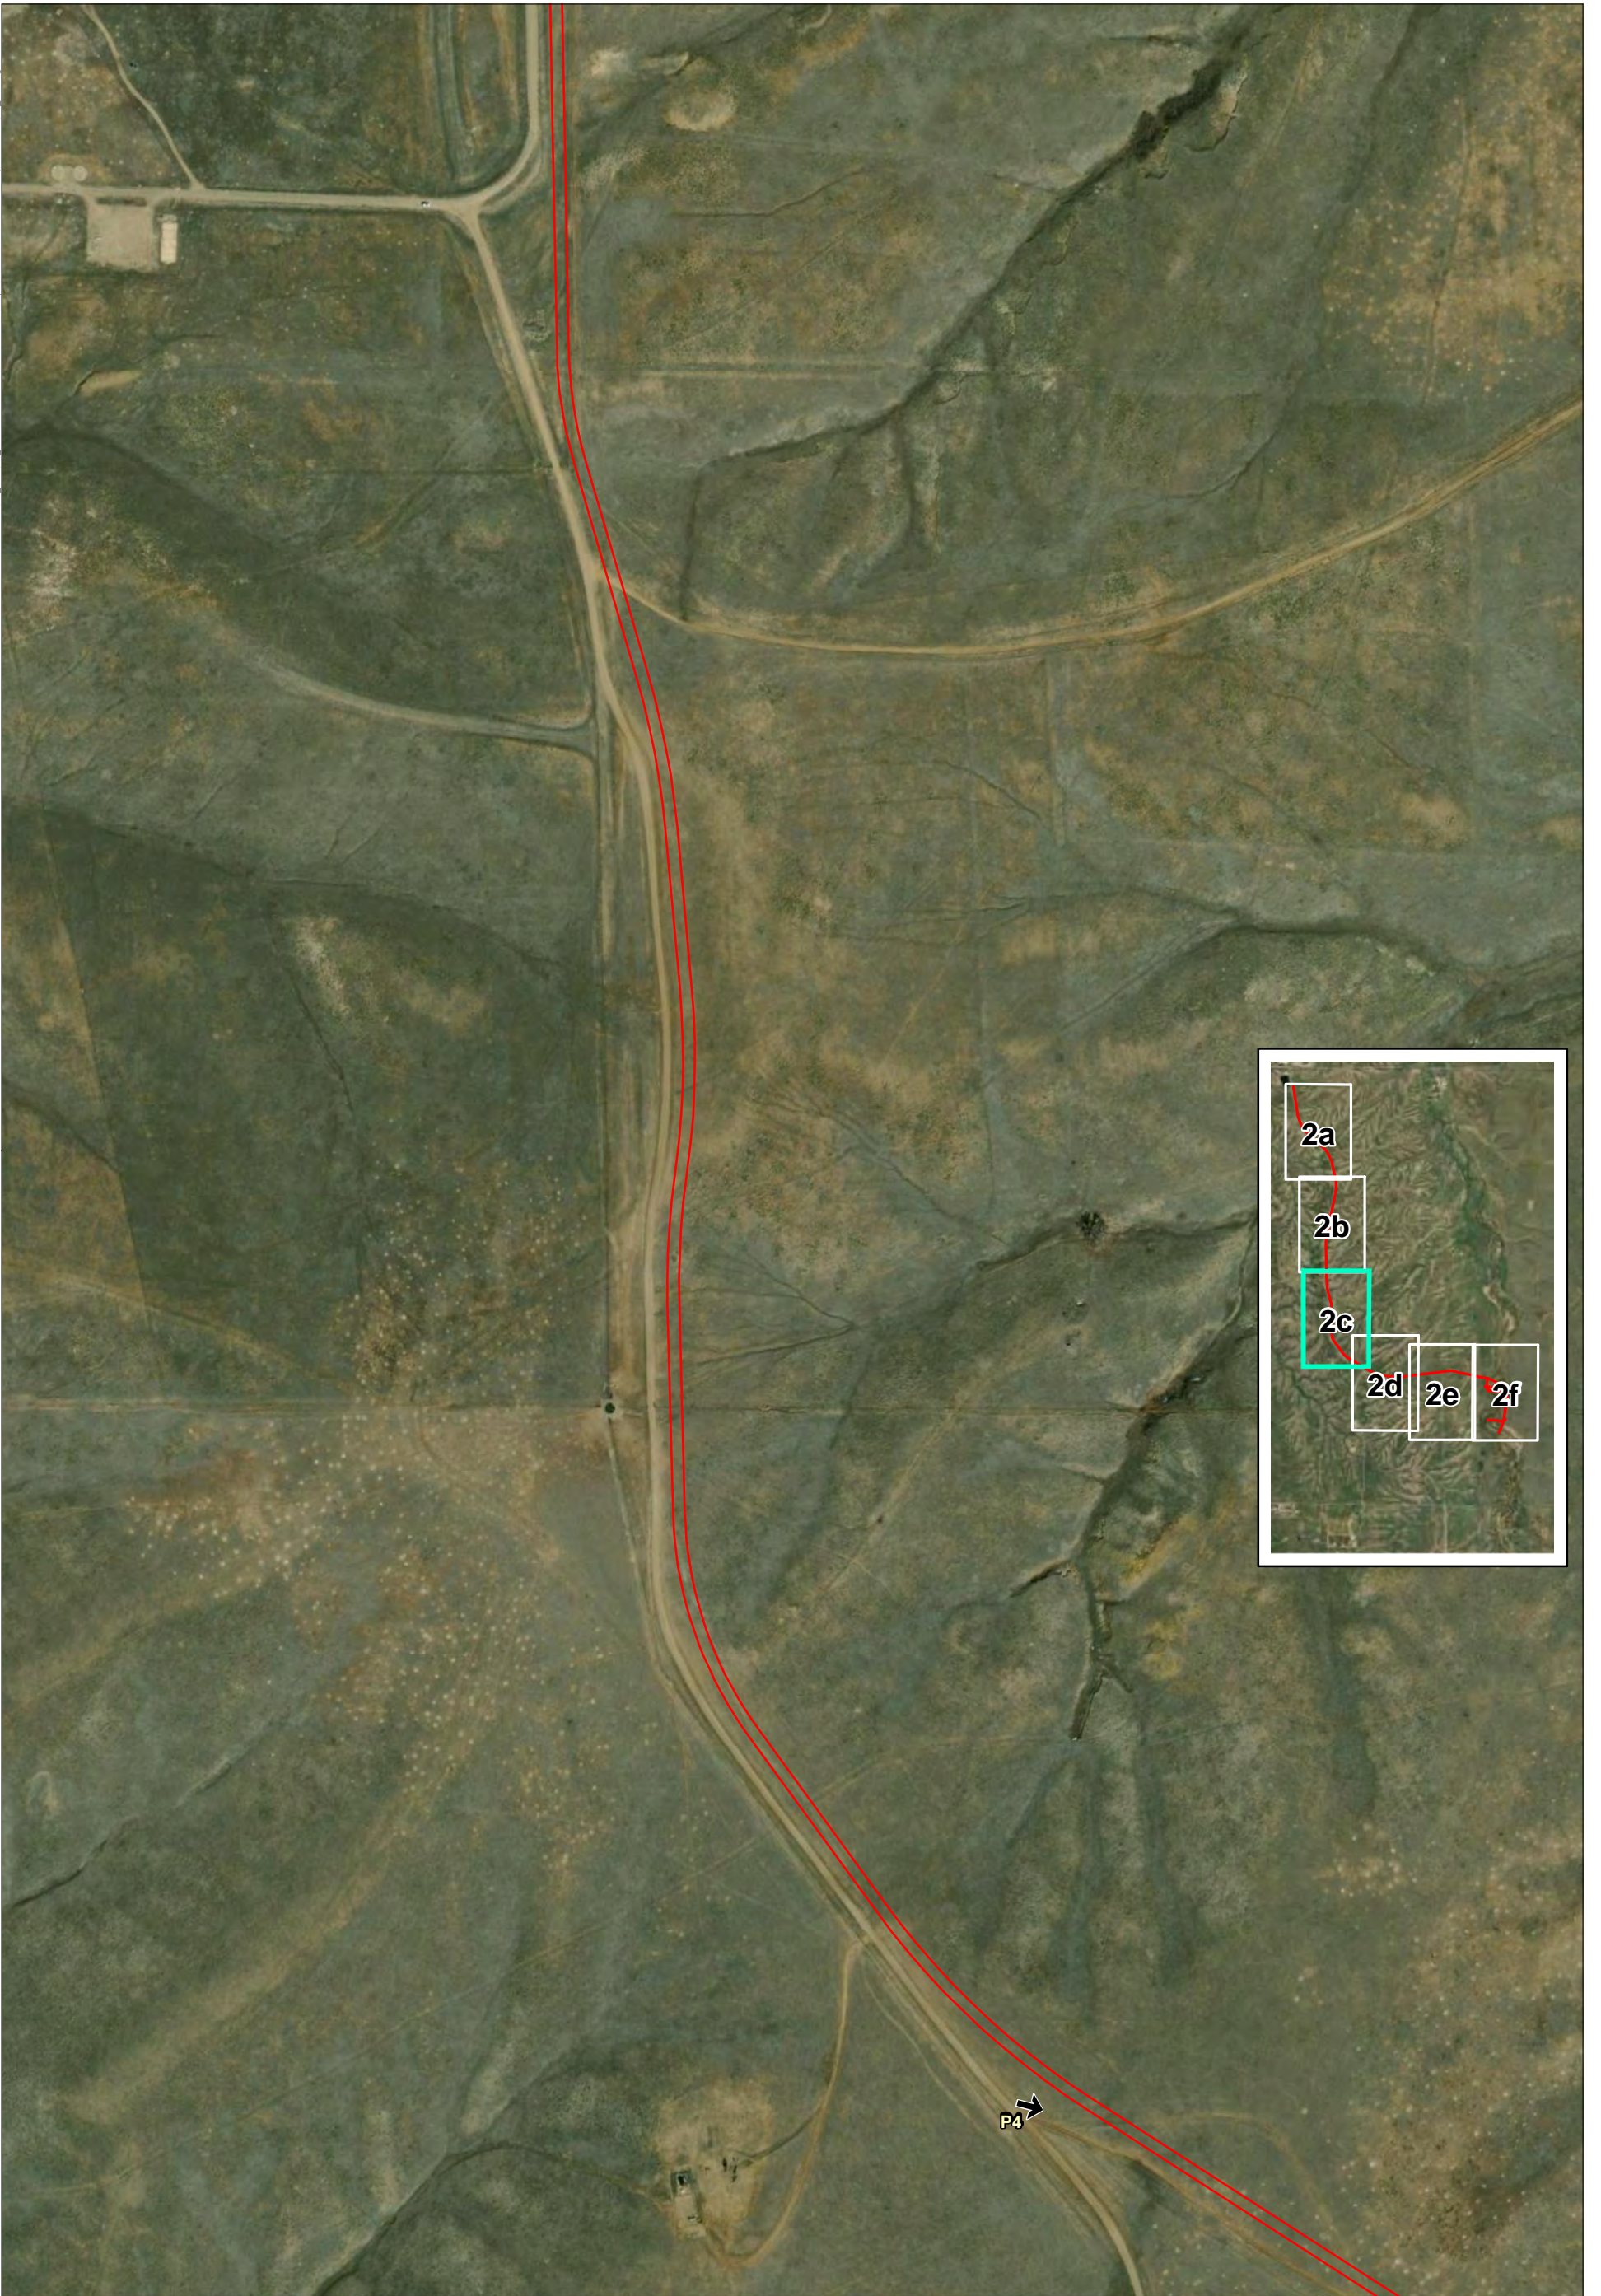
**Figure 2c
Existing Conditions**

- Data Point
- Limit of Delineation
- ➔ Photo Point
- 🐾 Active Prairie Dog Colony
- - - Upland Vegetated Swale
- Project Area

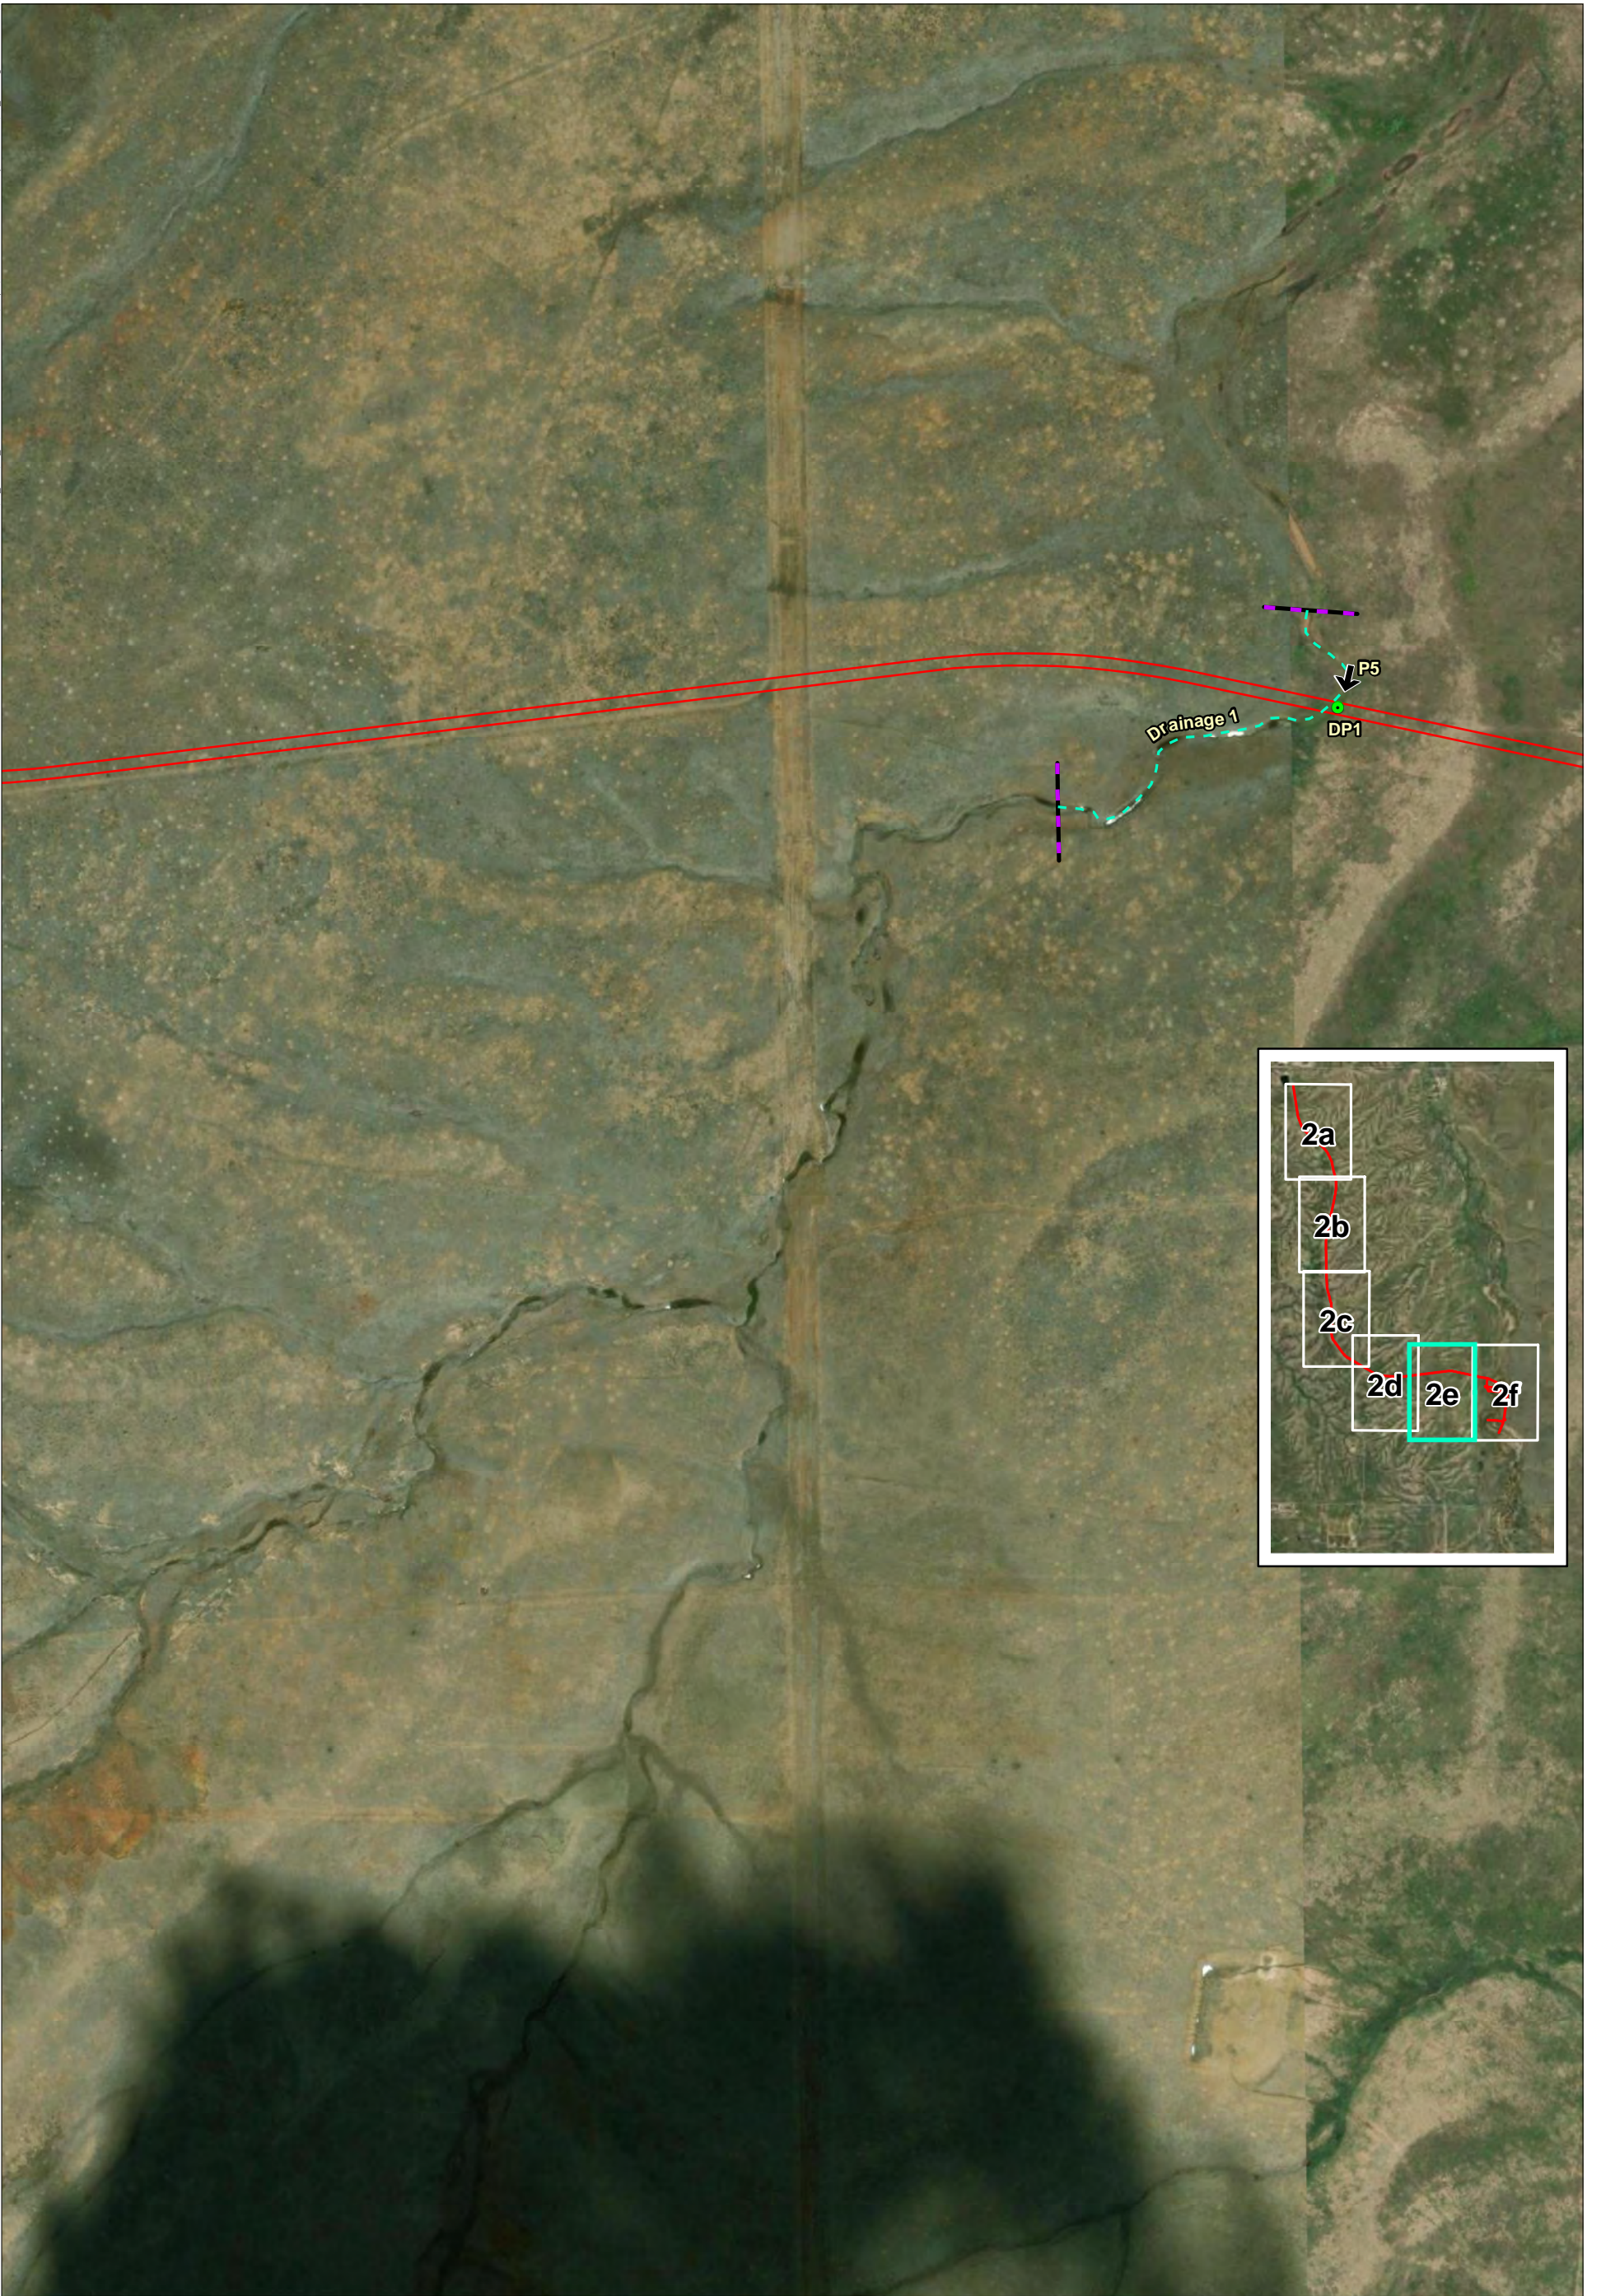
Figure 2e
Existing Conditions

- Data Point
- - - Limit of Delineation
- ➔ Photo Point
- 🐕 Active Prairie Dog Colony
- - - Upland Vegetated Swale
- Project Area

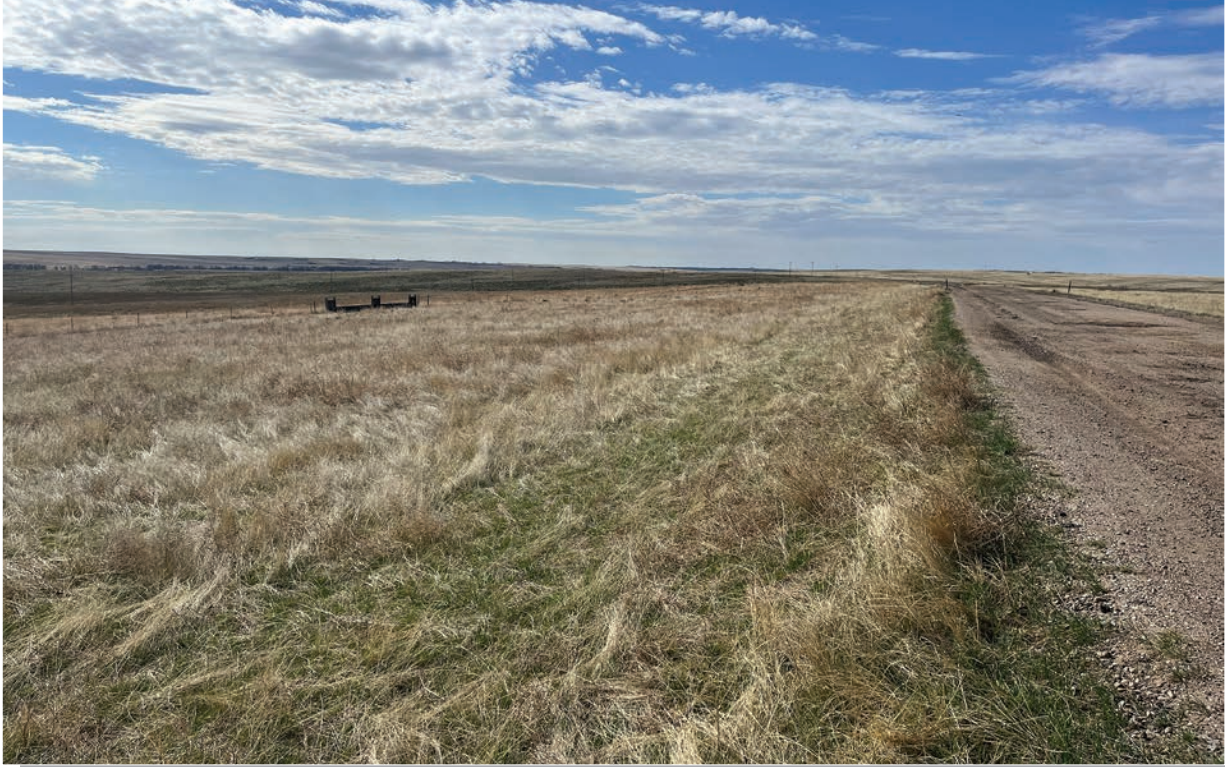
Photo 1 - Overview of uplands in the northern portion of the project area. View is to the southeast.

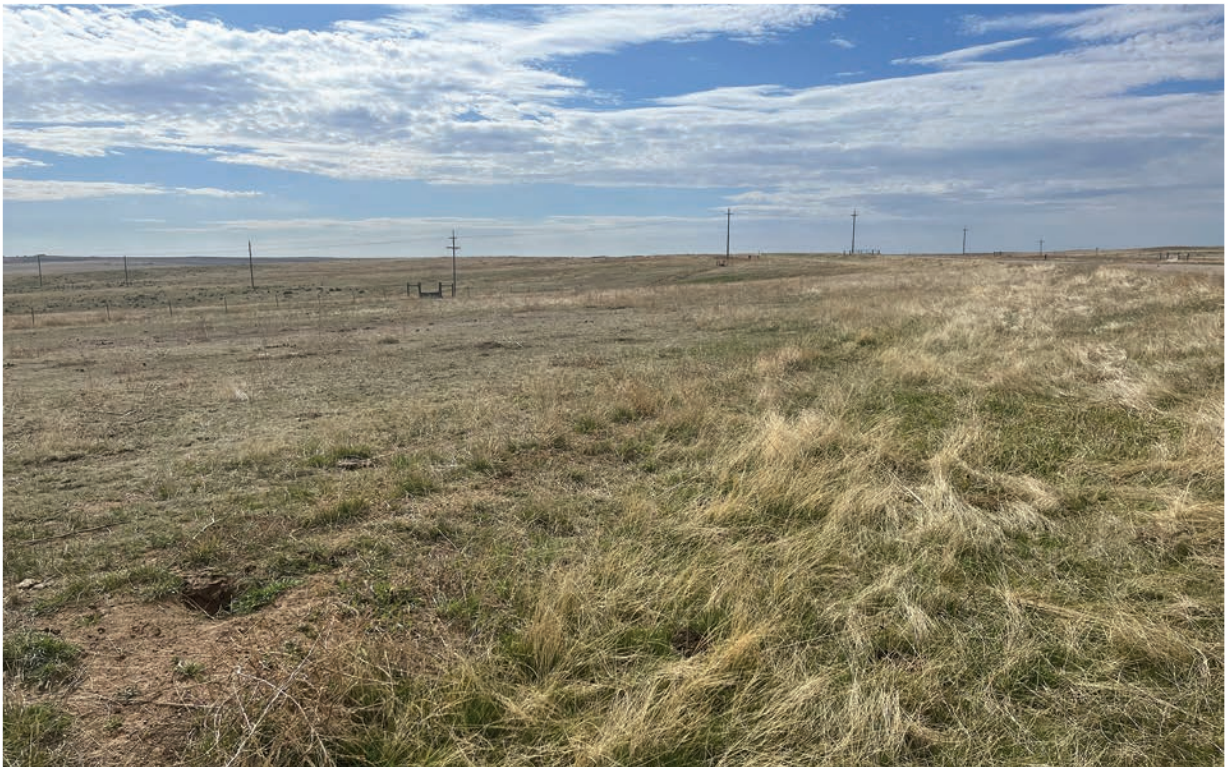
Photo 2 - Overview of uplands and active prairie dog colony in the northern portion of the project area. View is to the southeast.

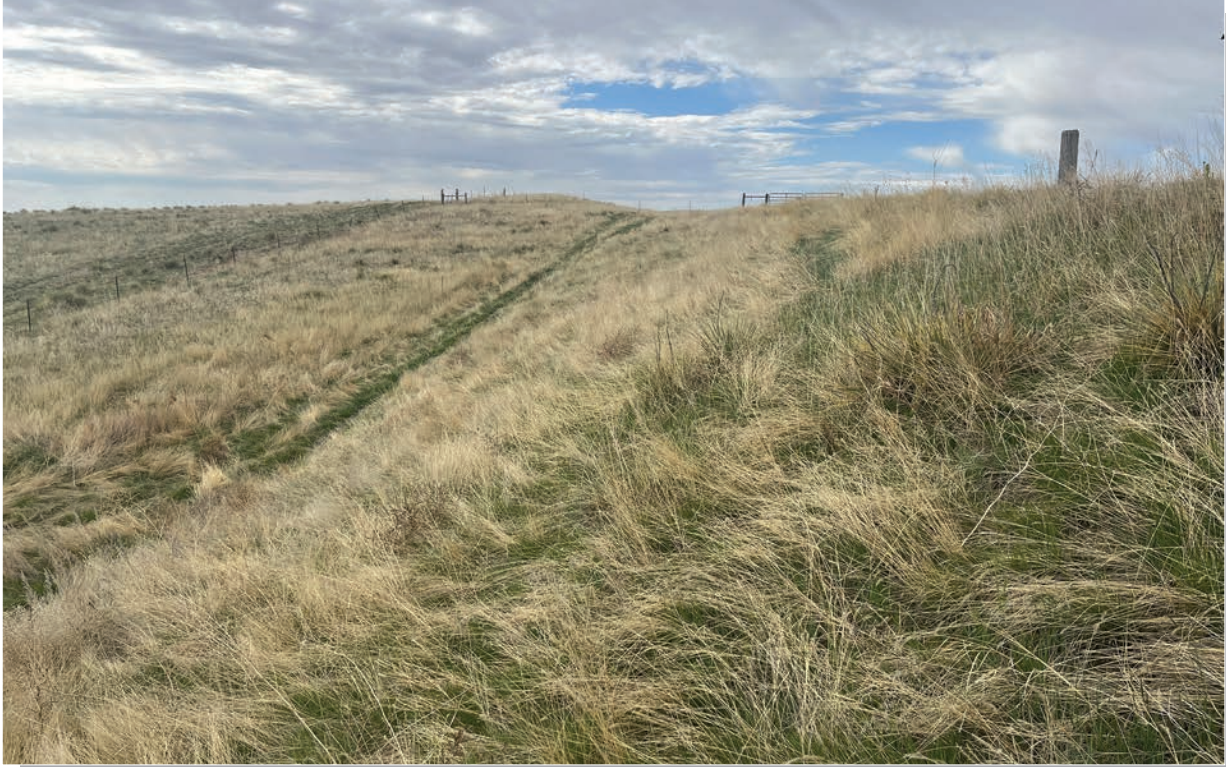
Photo 3 - Overview of uplands in the northern portion of the project area. View is to the southeast.

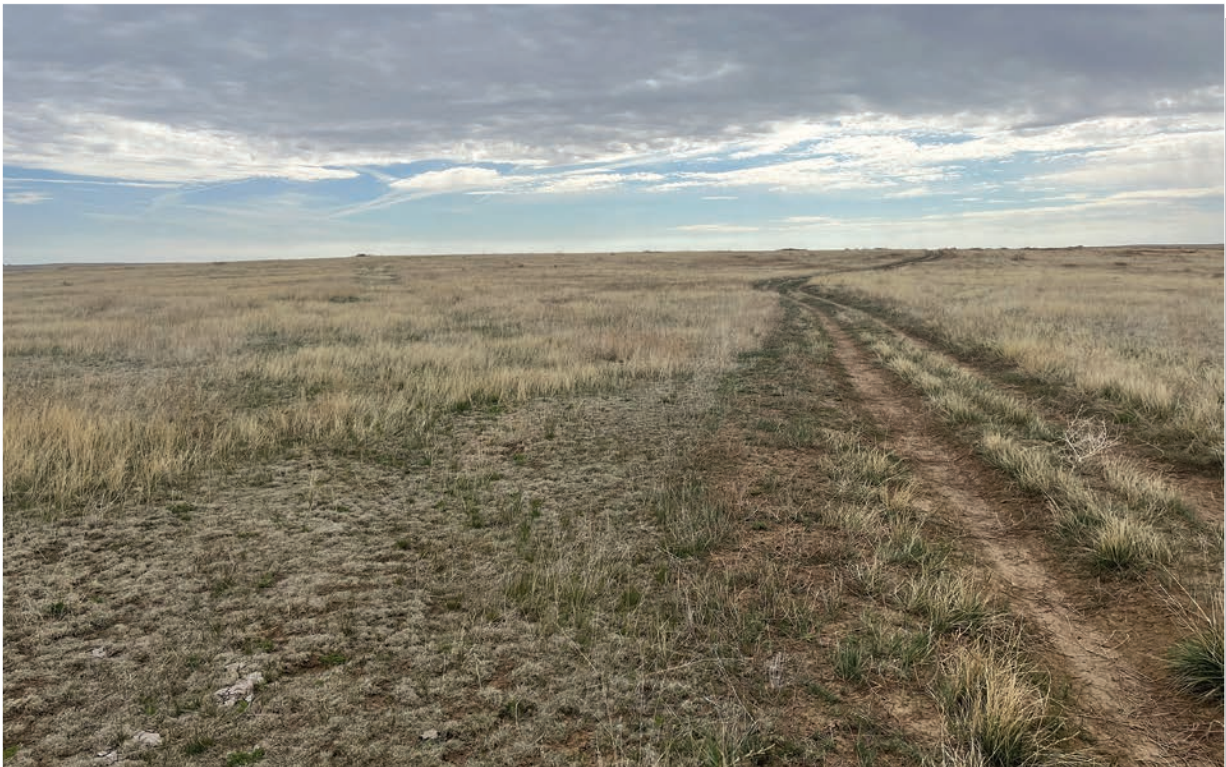
Photo 4 - Overview of uplands in the central portion of the project area. View is to the southeast.

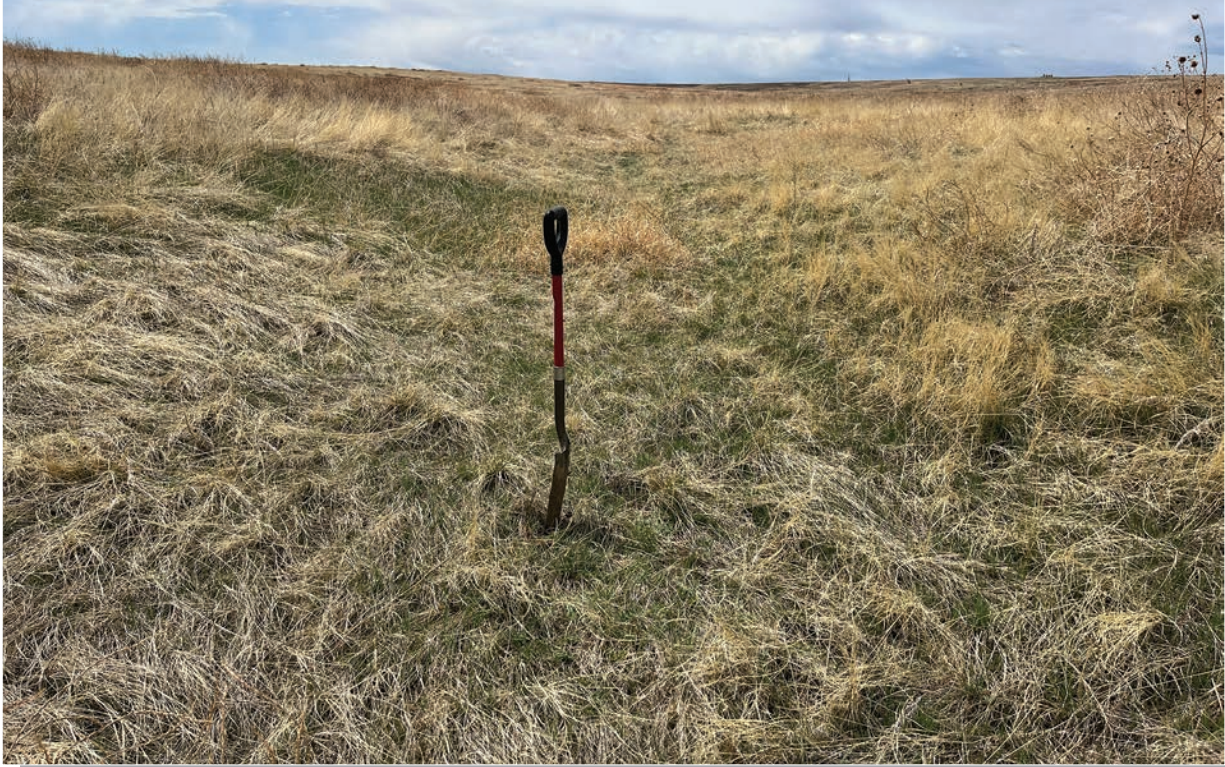
Photo 5 - Overview of Drainage 1 in the central portion of the project area. View is to the southwest.

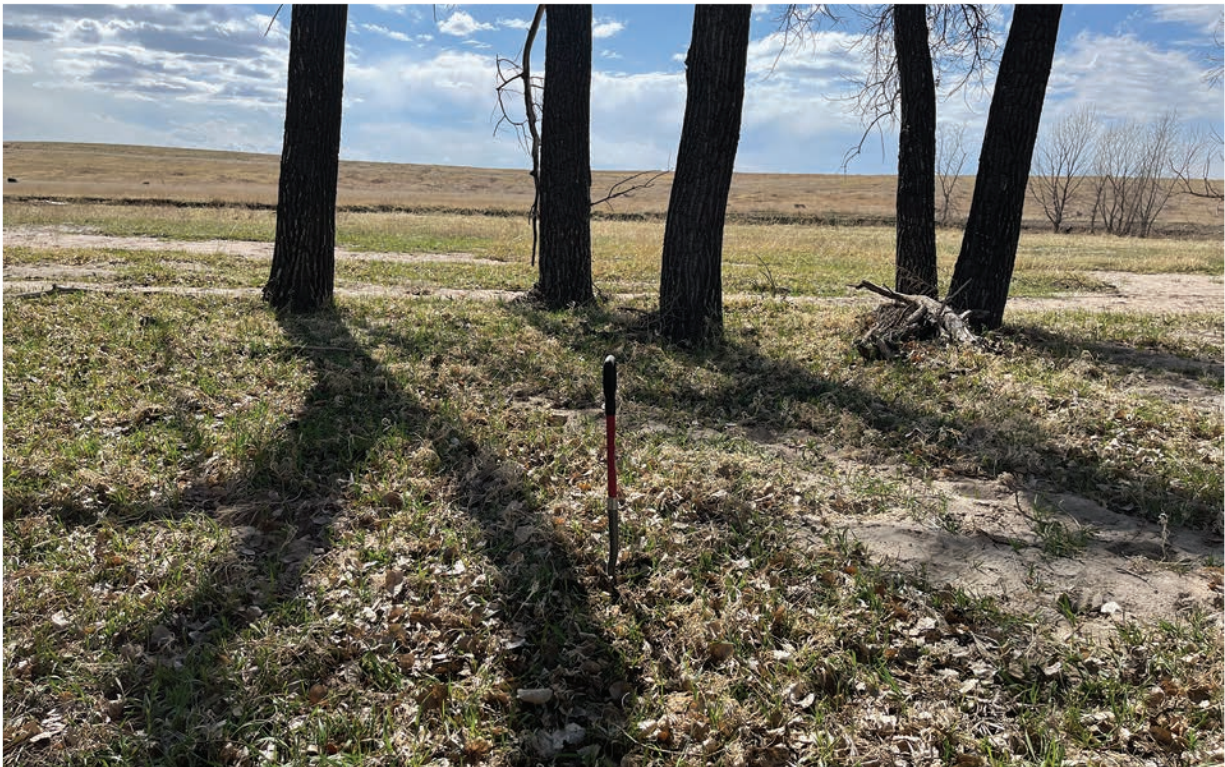
Photo 6 - Overview of uplands in the riparian corridor along the eastern boundary of Box Elder Creek in the southern portion of the project area. View is to the west.

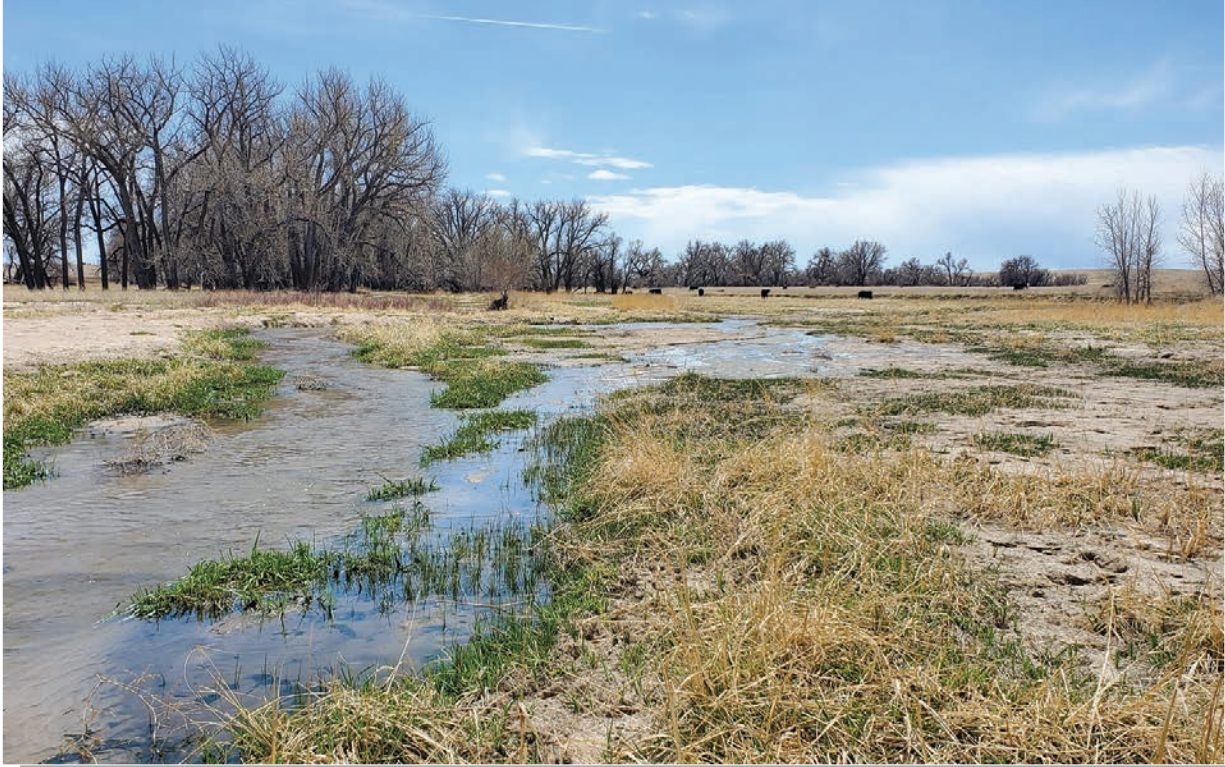
Photo 7 - Overview of wetlands along Box Elder Creek in the southern portion of the project area.
View is to the south.

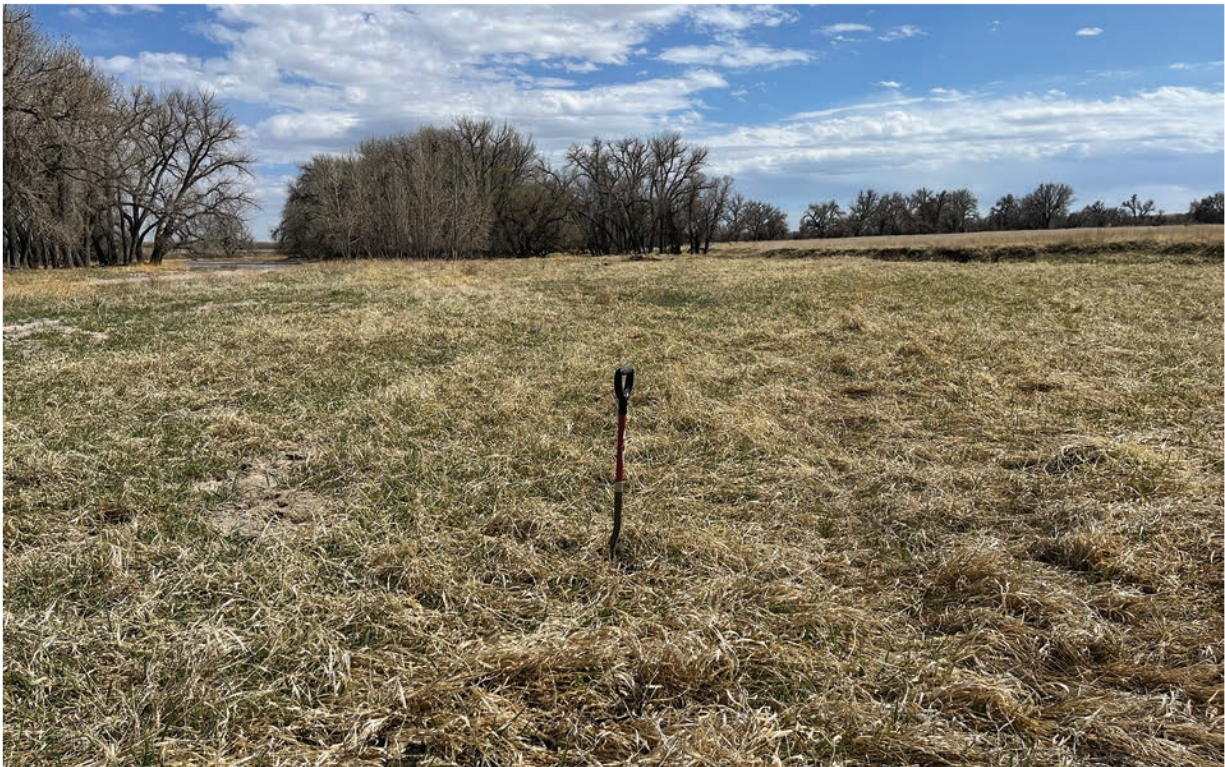
Photo 8 - Overview of wetlands along Box Elder Creek in the southern portion of the project area.
View is to the south.

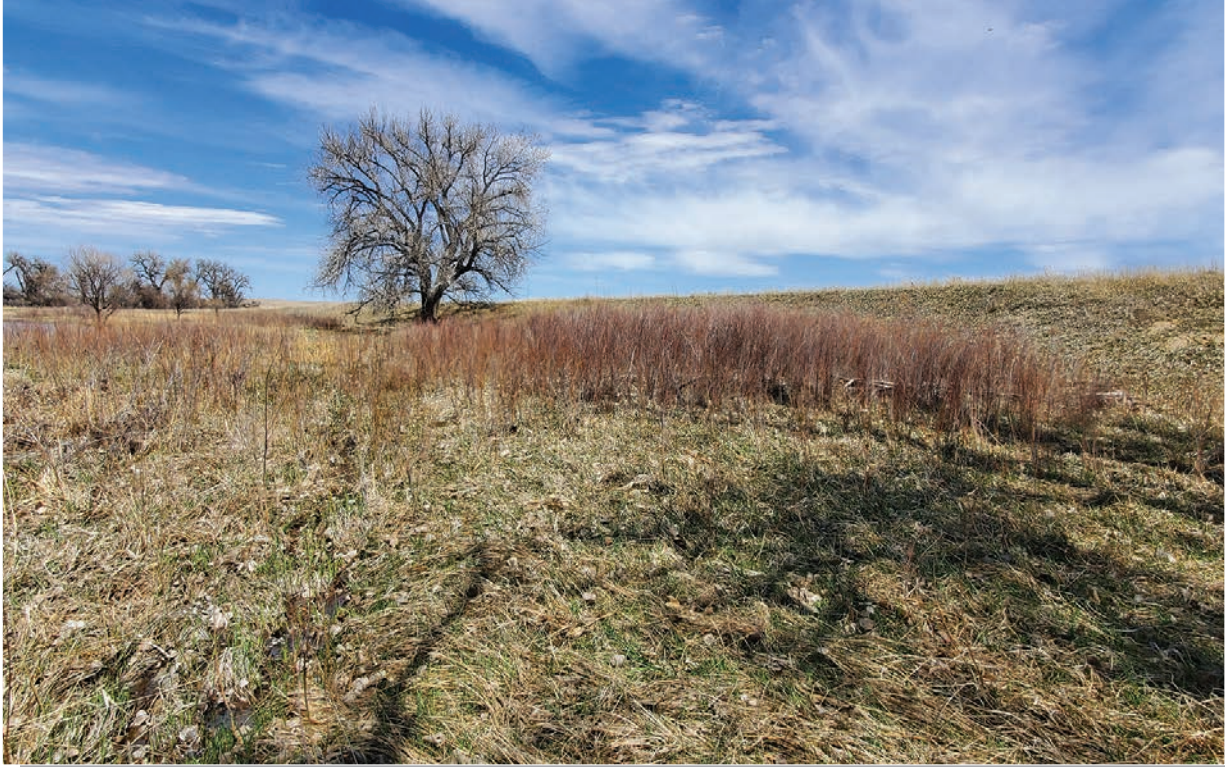
Photo 9 - Overview of wetlands along Box Elder Creek in the southern portion of the project area.
View is to the northeast.

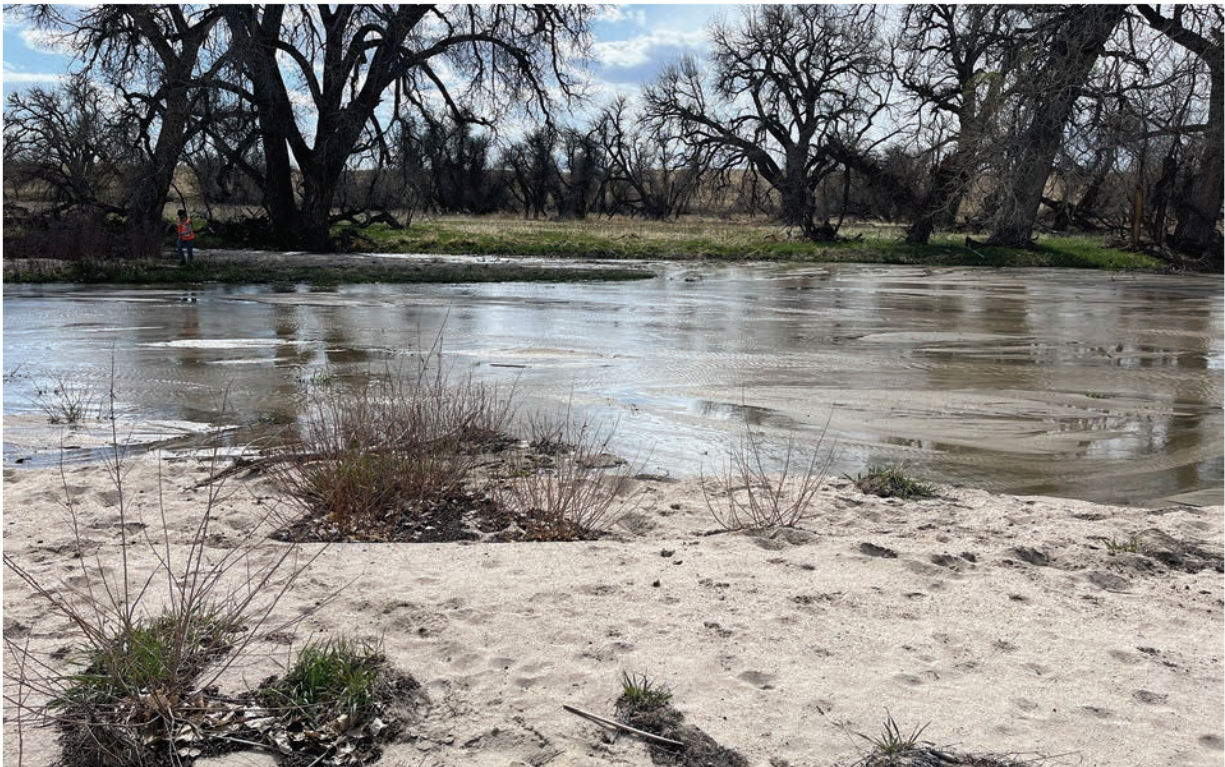
Photo 10 - Overview of wetlands along Box Elder Creek in the southern portion of the project area.
View is to the west.

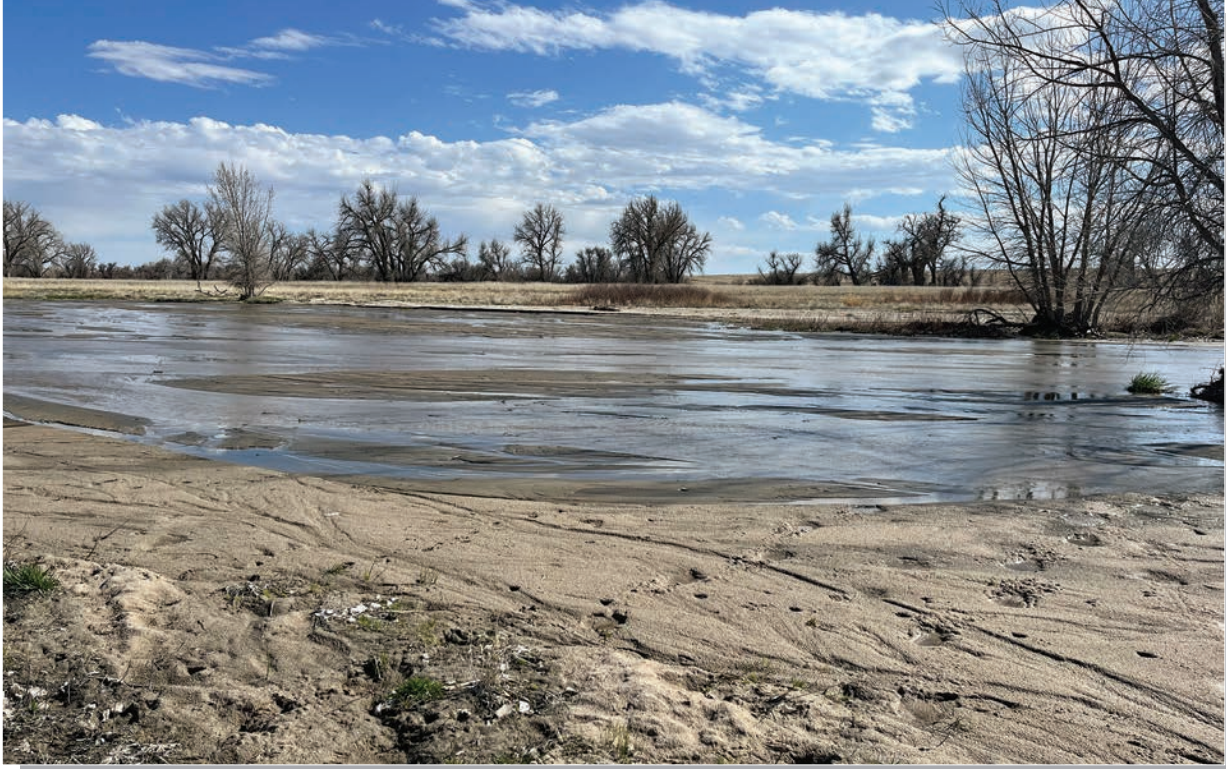
Photo 11 - Overview of Box Elder Creek in the southern portion of the project area. View is to the south.
