AQUATIC RESOURCE DELINEATION REPORT

Rangeview Metropolitan District
Box Elder Creek Diversion Dam

Noah Washko, Environmental Specialist
Pure Cycle Corporation
34501 E. Quincy Ave, Bldg 1, Ste D
Watkins CO 80137

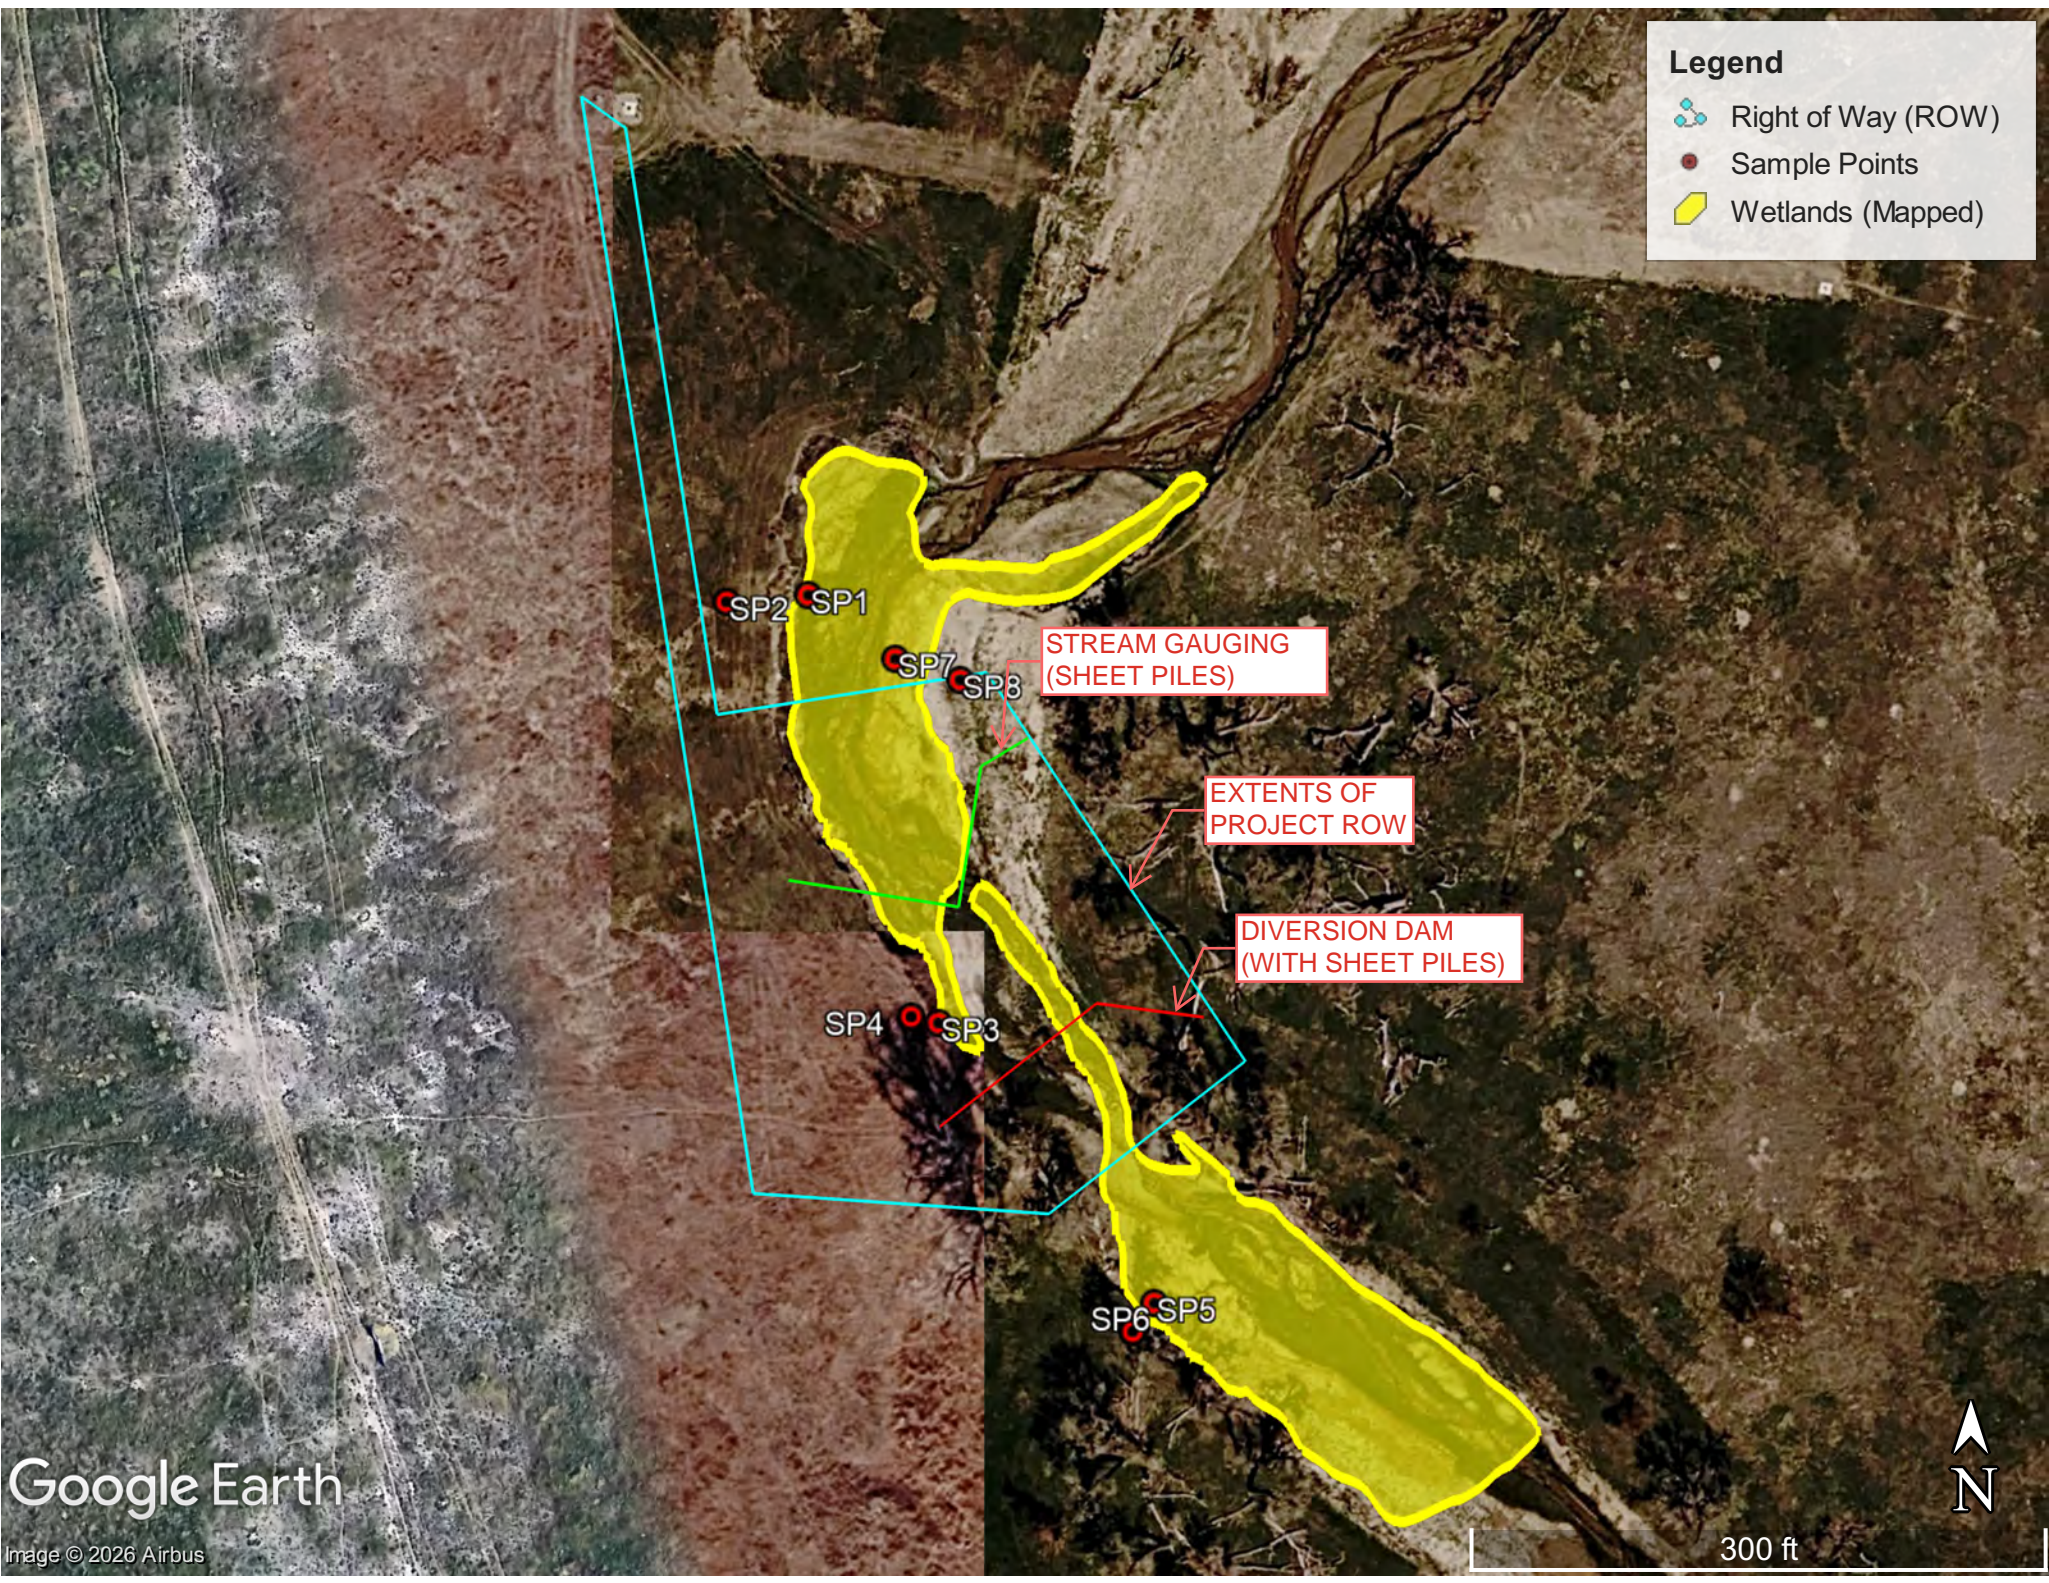
- Right of Way (ROW)
- Sample Points
- Wetlands (Mapped)

Wetlands were delineated within this reach of Box Elder Creek, with clear indicators of hydrophytic vegetation, hydric soils, and wetland hydrology observed. A distinct wetland boundary was established using multiple sampling plots located within the streambed and adjacent uplands. Soil within the floodplain was predominantly sandy alluvium, transitioning to loamier textures at upland sampling points. Overall, the diversion dam project footprint will disturb minimal wetland area (.02 acres) at its proposed location.

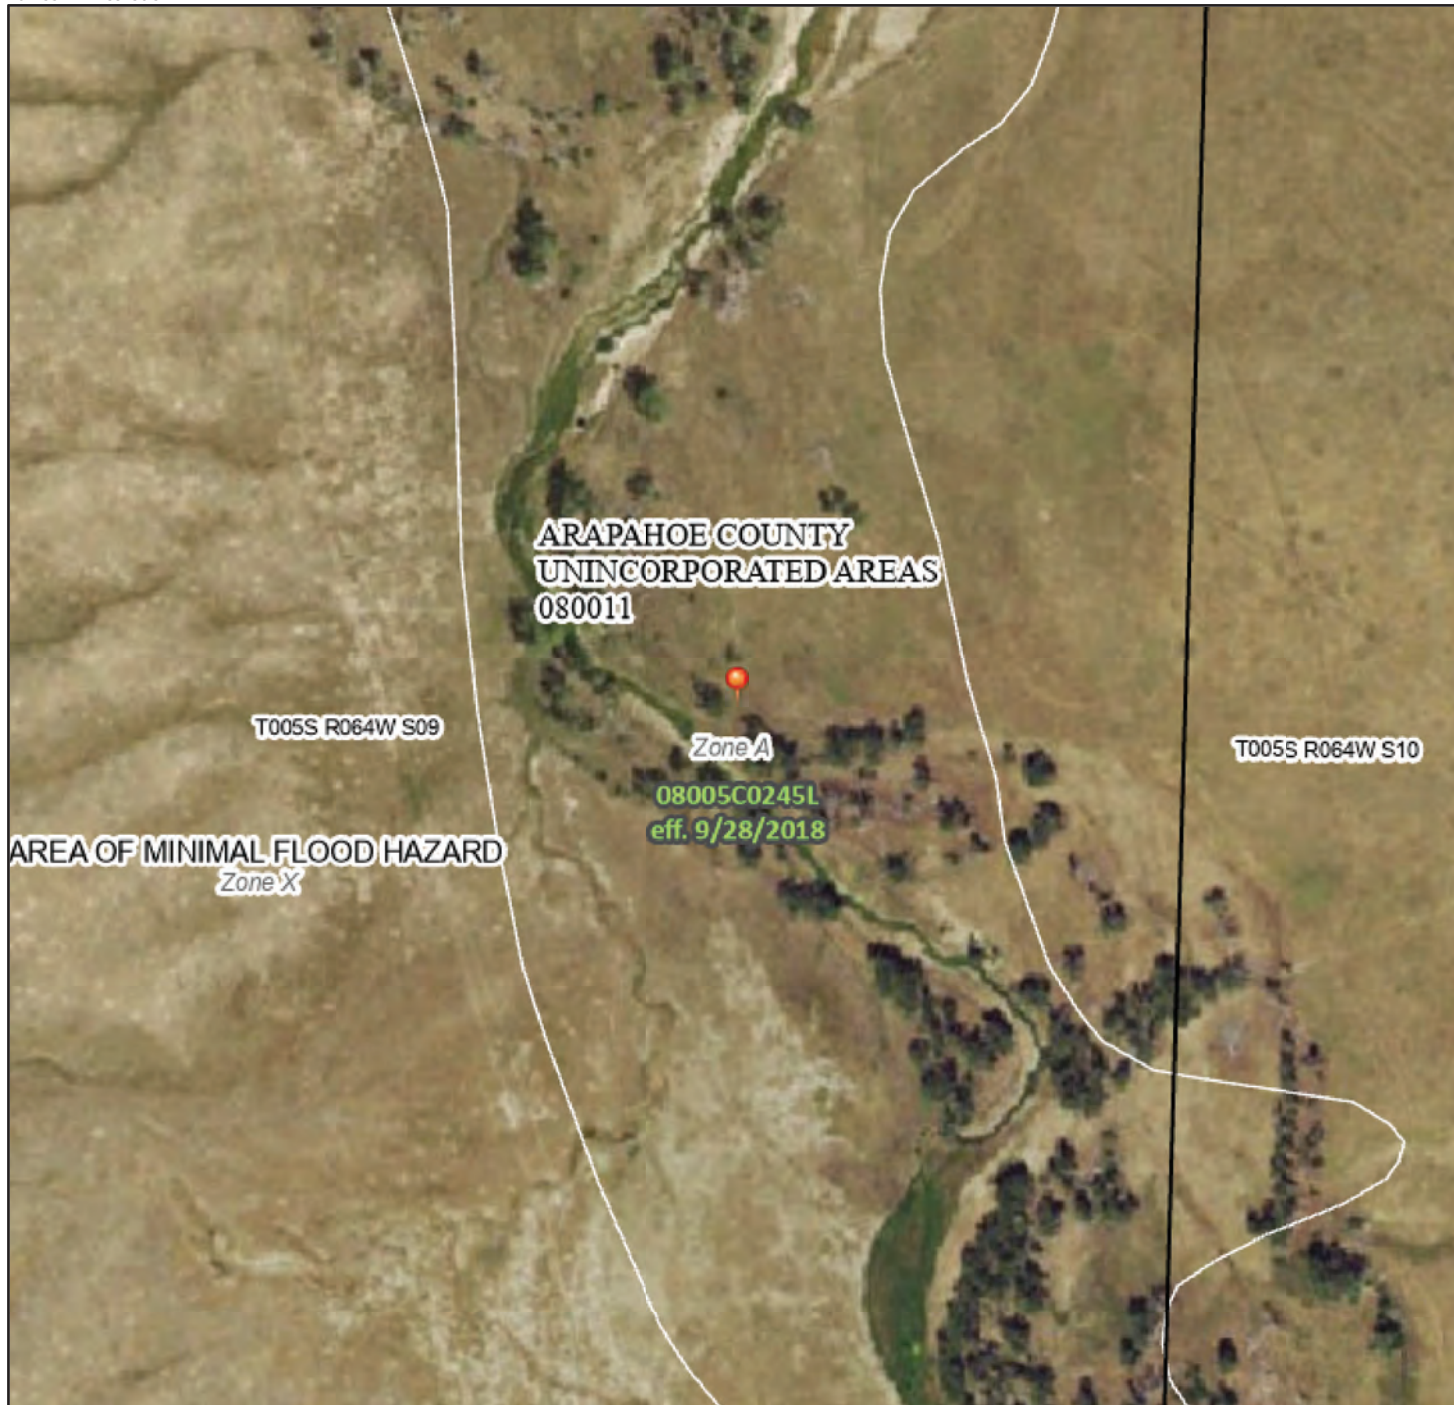
National Flood Hazard Layer FIRMMette

SPECIAL FLOOD HAZARD AREAS		Without Base Flood Elevation (BFE) <i>Zone A, V, A99</i>
		With BFE or Depth <i>Zone AE, AO, AH, VE, AR</i>
		Regulatory Floodway

OTHER AREAS OF FLOOD HAZARD		0.2% Annual Chance Flood Hazard, Areas of 1% annual chance flood with average depth less than one foot or with drainage areas of less than one square mile <i>Zone X</i>
		Future Conditions 1% Annual Chance Flood Hazard <i>Zone X</i>
		Area with Reduced Flood Risk due to Levee. See Notes. <i>Zone X</i>
		Area with Flood Risk due to Levee <i>Zone D</i>

OTHER AREAS		NO SCREEN Area of Minimal Flood Hazard <i>Zone X</i>
		Effective LOMRs
		Area of Undetermined Flood Hazard <i>Zone D</i>

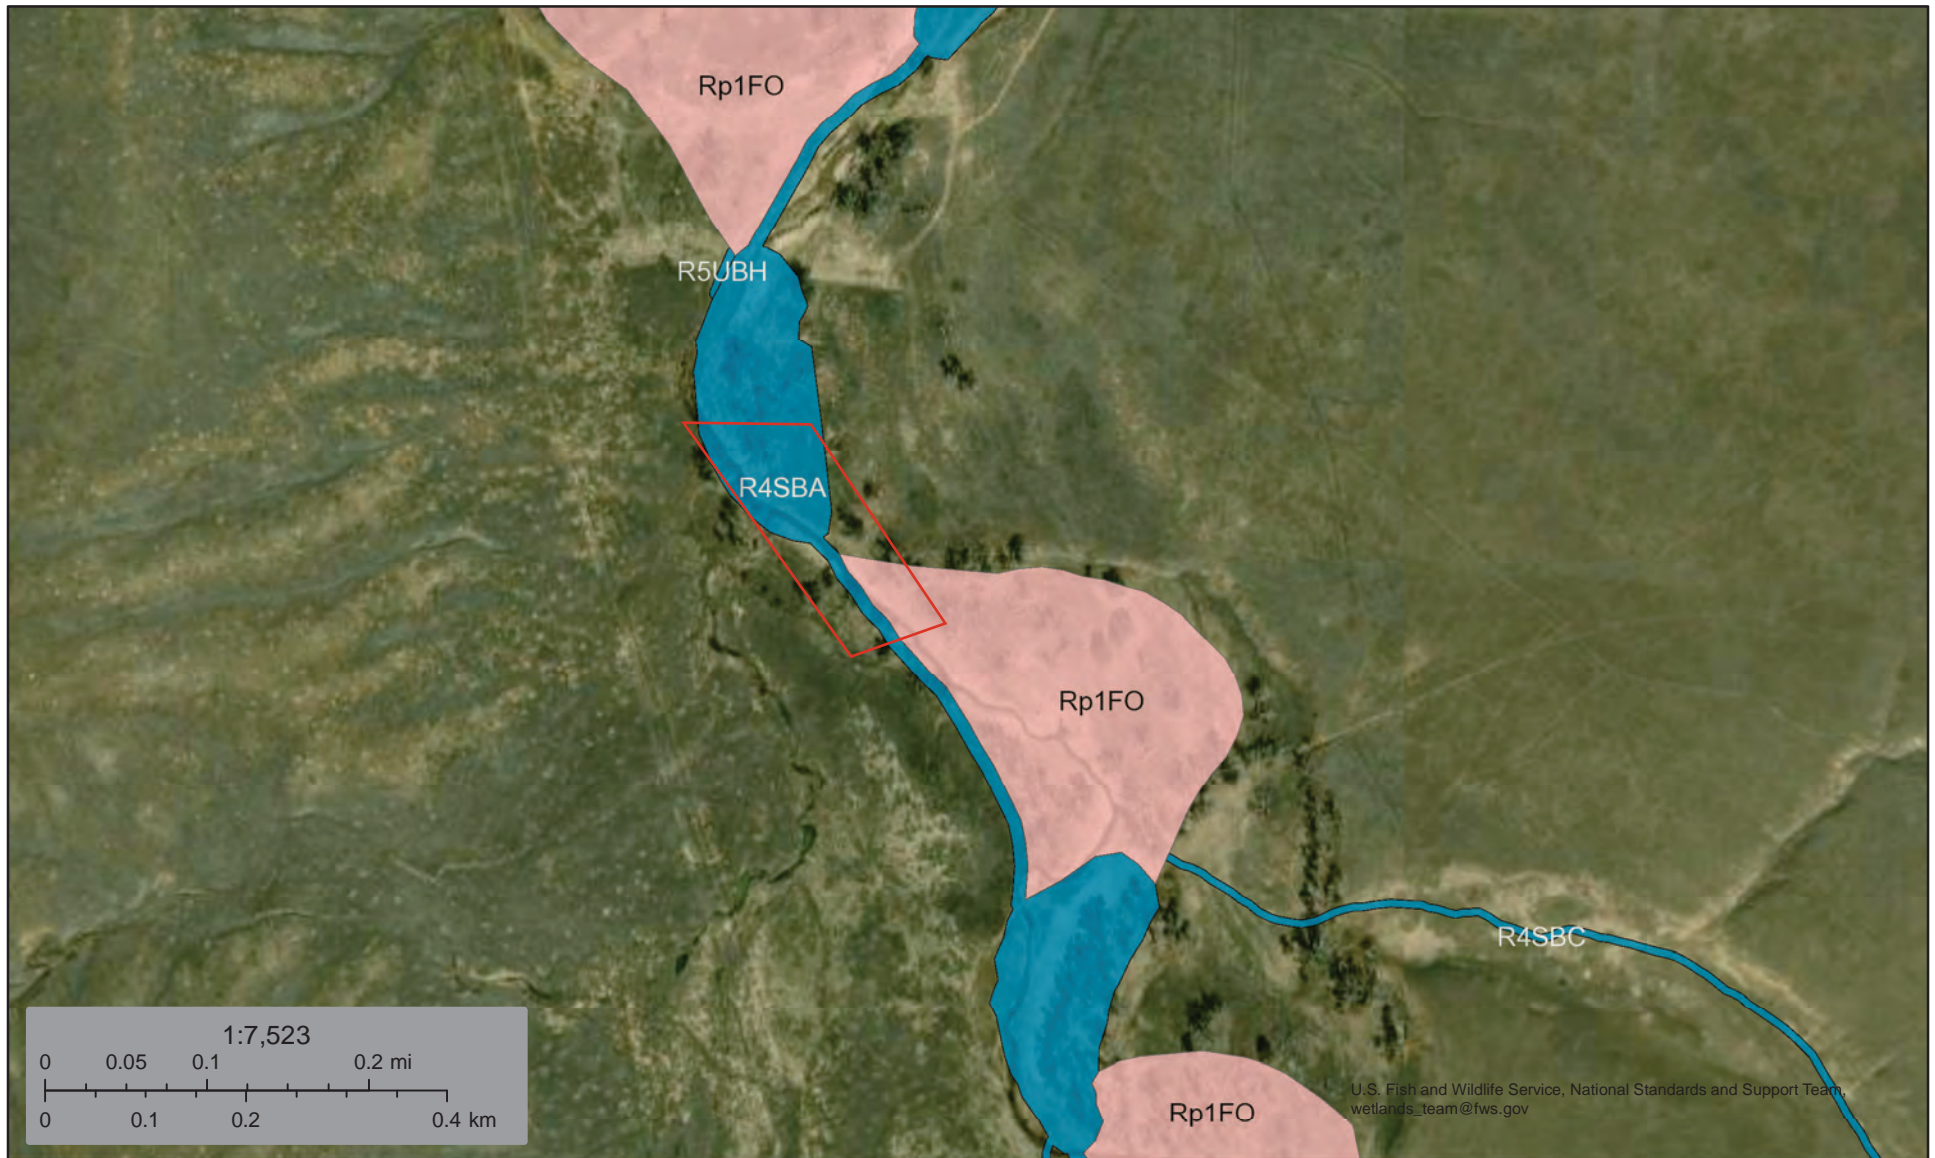
This map is for general reference only. The US Fish and Wildlife Service is not responsible for the accuracy or currentness of the base data shown on this map. All wetlands related data should be used in accordance with the layer metadata found on the Wetlands Mapper web site.

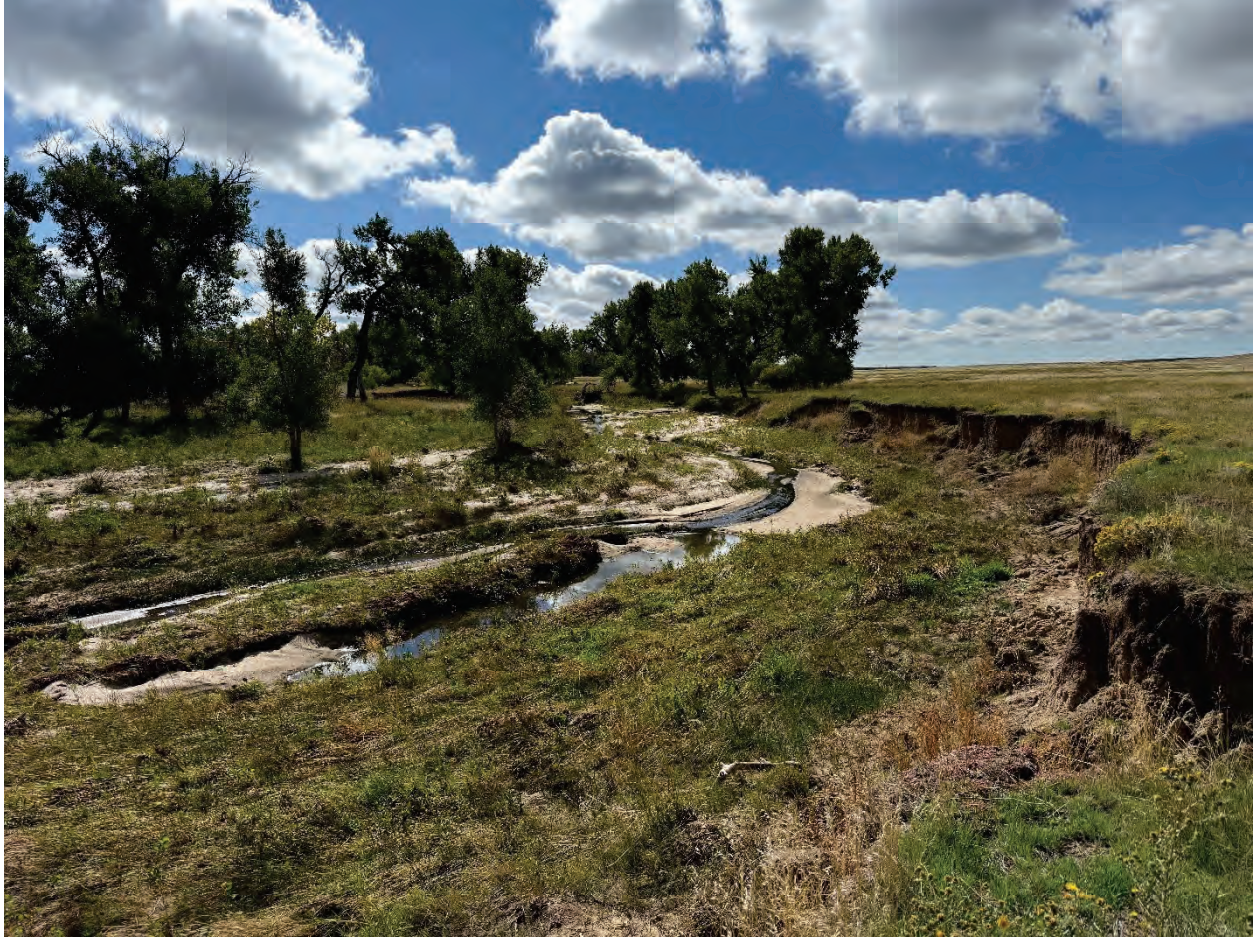
Photo 1. View of the wetlands and OHWM within Box Elder Creek, facing southeast.

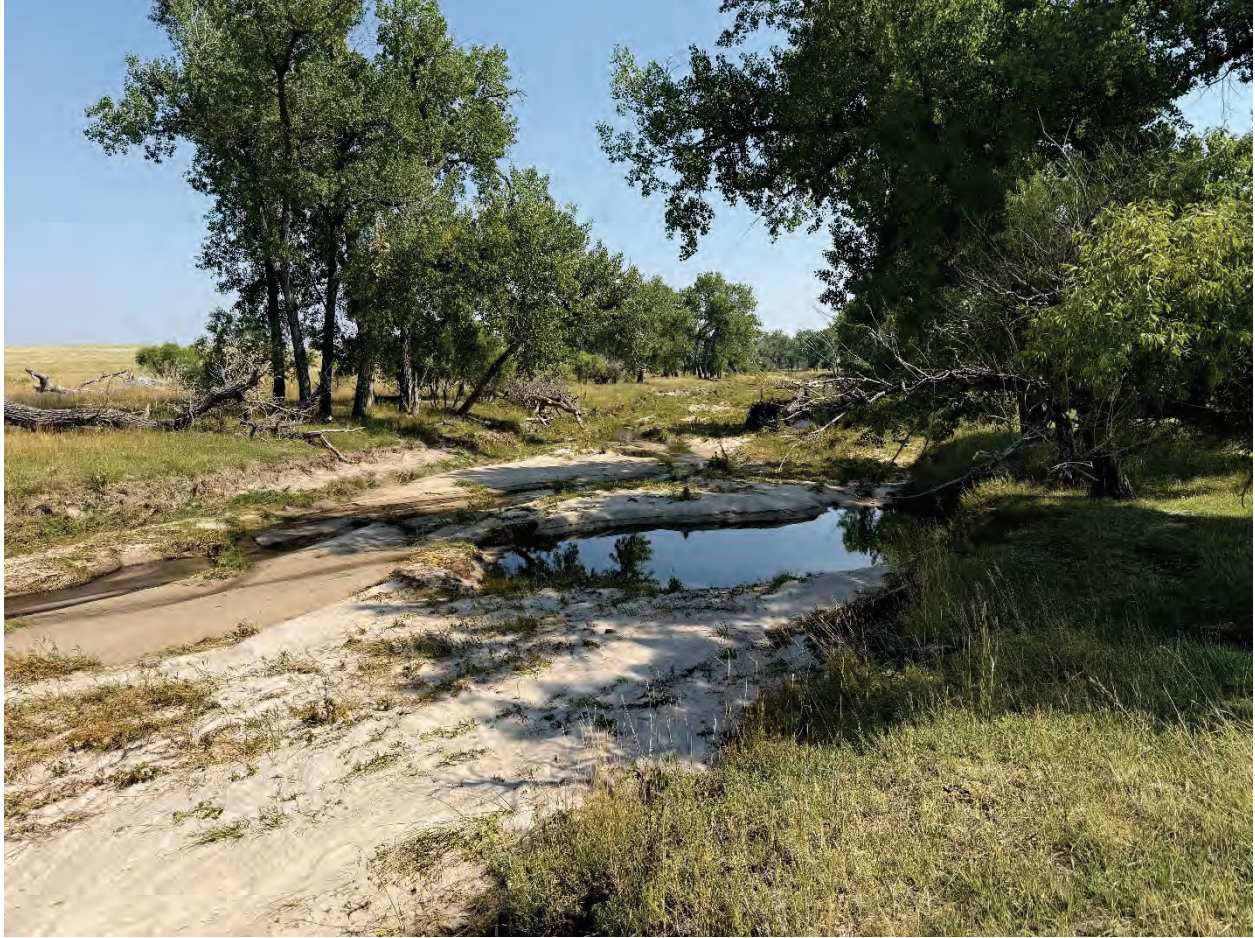
Photo 2. View of the proposed diversion dam site within the creek, facing southeast. The majority of the project footprint will be constructed on alluvial sand deposits devoid of vegetation.

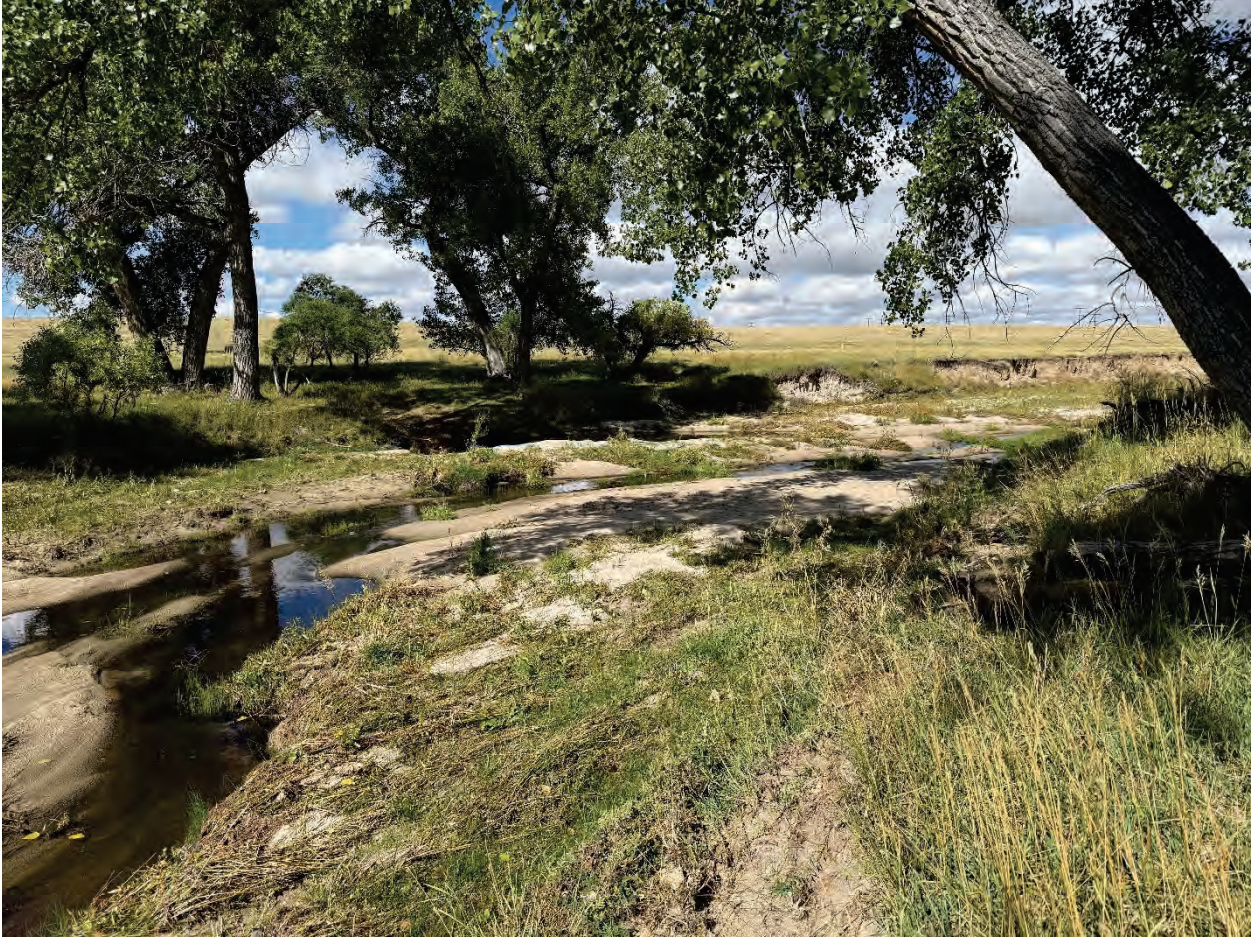
Photo 3. View of the wetlands and uplands from the southern portion of the project area, facing northwest.

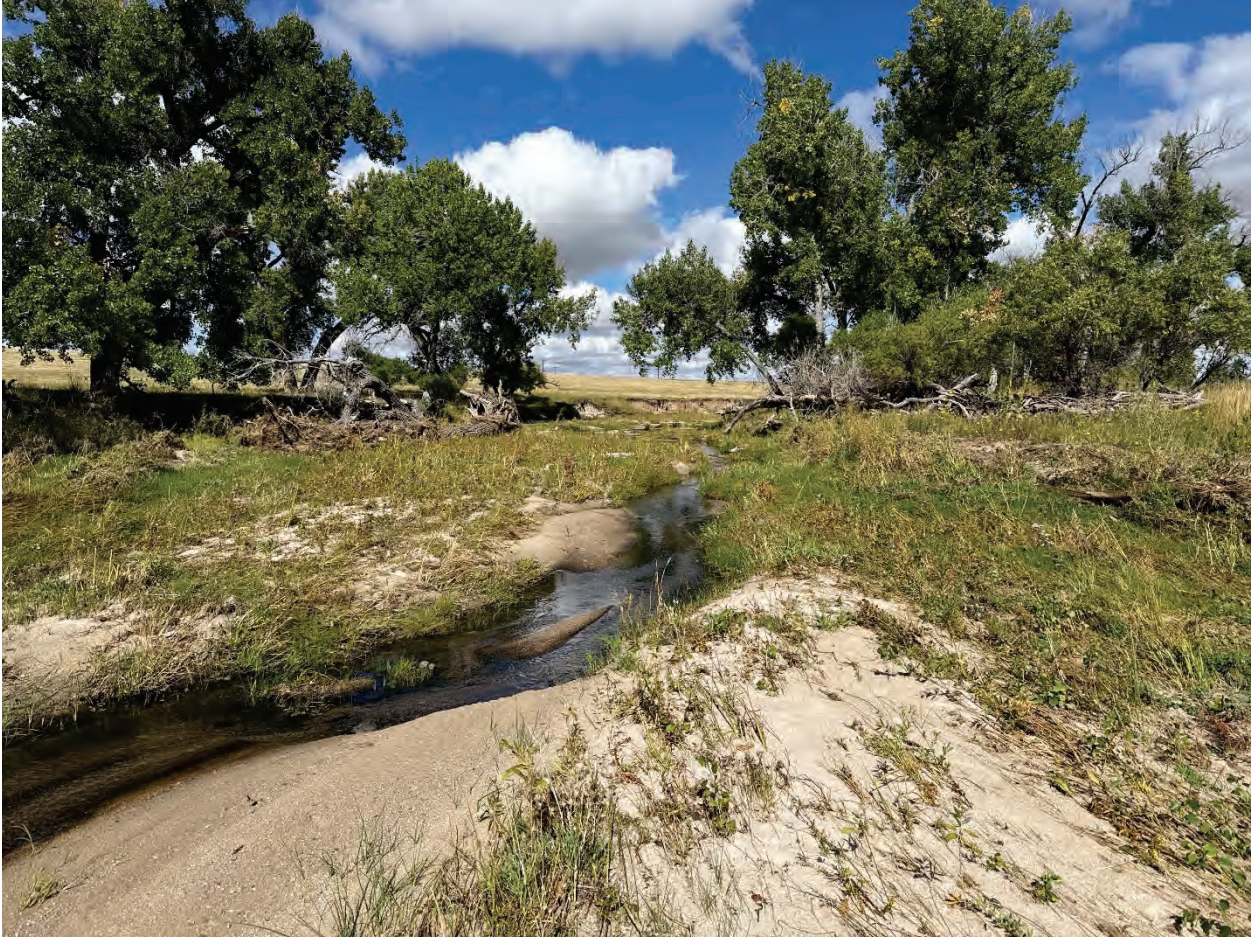
Photo 4. View of the wetlands in the southernmost portion of the project area, facing northwest.
